**service reference book
session no. 105**

POWERFLITE,

POWER STEERING

BRAKE SERVICE

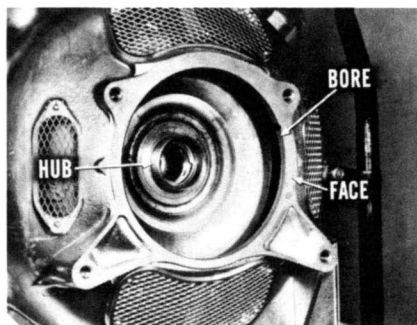
An oil leak at the front of the PowerFlite transmission, regardless of the make or model of the car, could be due to a worn front pump housing seal. Before installing a new seal, it is wise to check the cause of the leak first. It could be due to misalignment, or to a rough surface on the converter hub.

In other words, in addition to inspecting the surface of the hub, you'd want to check for excessive runout of the torque converter hub. Misalignment could result in excessive runout at the bore of the converter housing, or at the rear face of the housing.

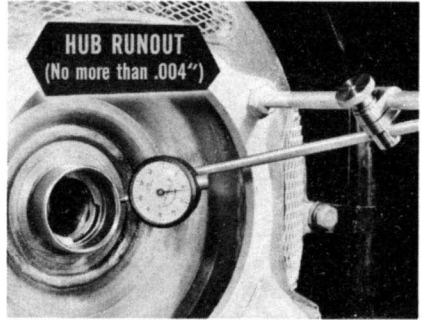
Check Hub Runout—You have to remove the transmission to install a new front pump housing seal anyway, so while the transmission is out, check runout of the converter hub. Screw the dial indicator

rod in the converter housing, and place the anvil of the indicator on the hub. Turn the converter one complete revolution two or three times, and watch the indicator. Hub runout shouldn't be more than four thousandths. If it is, drain the converter. Then, mark the low spot and turn the converter until the mark is directly down. Use an acetylene torch with a No. 3 tip set at maximum heat to heat the front of the converter. Do this through the opening in the adapter plate.

Usually, you'll heat a spot about 1/2" in diameter until it is a dull red. Next, quench the area quickly with wet rags to shrink the hub back into line. Recheck hub runout with the dial indicator when the converter returns to a uniform room temperature.

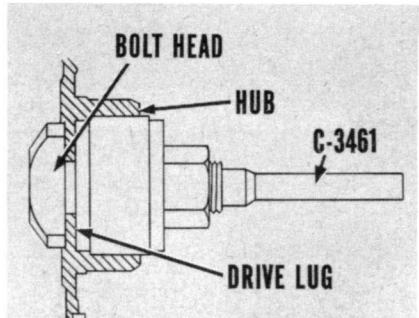
Check Bore Runout — Once you're sure hub runout is within limits, you can go ahead and check runout at the bore. To check bore runout, use a fixture and a dial indicator. Mount the fixture inside the converter so the head of the bolt is behind the converter pump drive lugs.

With a wrench, hold the flat end of the fixture bolt and tighten the nut. Then, mount the indicator on end of the bolt. Set the dial anvil so it bears on the transmission pilot bore of the converter housing. Then, turn the converter a full turn two or three times and take your readings. There should be no more than .010" total indicator reading. If it is more . . . say about .018" total reading, you'll have to shift the housing on the adapter plate in a direction opposite the point you noticed the maximum runout indication. Shifting the housing is done by first replacing the two steel dowels.

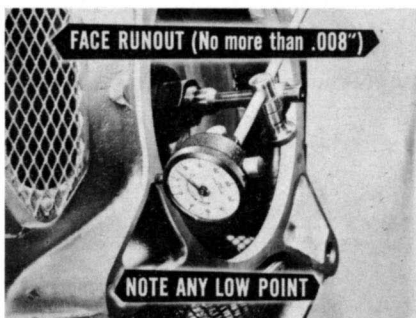
Check Face Runout — You'll have to mount the indicator differently to check runout on the face of the housing. Set the anvil so it bears on the rear face, $\frac{1}{4}$ " beyond the bore. Then, rotate the converter a full turn two or three times and check your readings.

Face runout shouldn't be more than $.008$ ". Make a note of any low points because you'll be using shims there to square up the transmission.

What you do is slip shims over the bolt between the housing and transmission case. The thickness of shims you pick depends on the runout reading. For the correct location and shim thickness to use, refer to the following table.

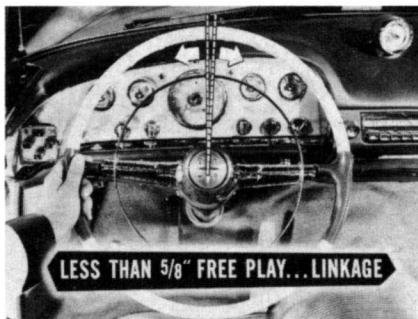
“Wandering”—On any car equipped with Coaxial Power Steering, binding or looseness in the system can cause occasional “wandering”. One of the symptoms of this condition is too much steering wheel “free play”. Another is the fact that the steering wheel requires constant turning to keep the car going in a straight-ahead direction.

For example . . . if there's *less than 5/8"* free play at the steering wheel with the engine running . . . and you know the car wanders, the linkage is either loose or binding somewhere.

On the other hand, if free play at the steering wheel rim is *more than 5/8"*, *without moving the linkage*, the power unit is at fault.

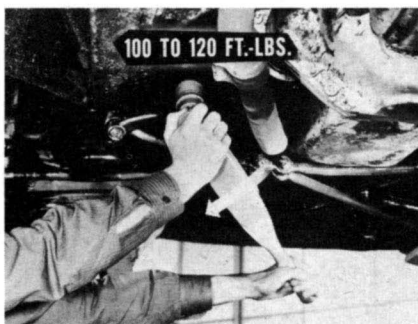
Check the Linkage—To check the linkage, raise the car. Then, visually—and by “feel”—check the entire linkage system. Look for looseness. The steering gear arm, for instance, should be tight on the gear shaft. If it isn't, tighten the nut 100 to 120 foot-pounds.

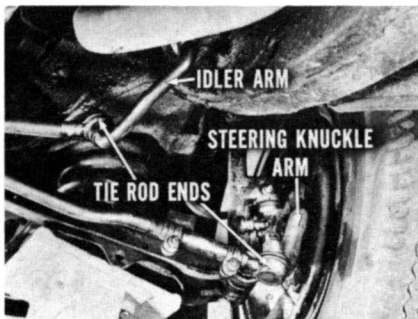
Check also for a bind or looseness at the idler arm. Besides that, look for loose or cocked tie rod ends . . . or loose steering knuckle arms. Tighten or replace any faulty parts.

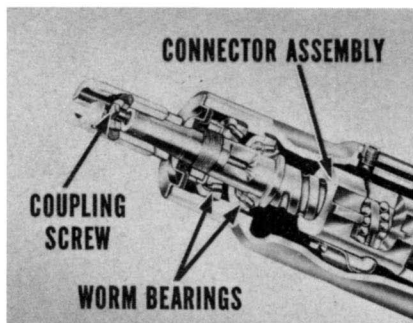
Check the Power Unit—Remember, more than $\frac{5}{8}$ " free play at the wheel, with the engine running and without moving the linkage, points to looseness in the power unit. There might be a loose gear shaft adjustment, for example.

Besides that possibility, the steering worm coupling screw might be loose. In addition, there might be a loose worm bearing preload adjustment. Also, the worm shaft in the connector assembly might have too much end play.

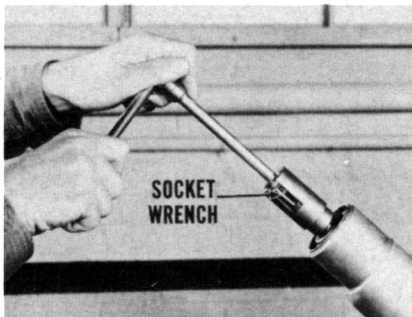
Check the steering worm coupling screw next. If it had worked loose, there would be too much backlash in the tube and coupling. In this case all you have to do is use a socket wrench and make sure the screw is snugged down good and tight.

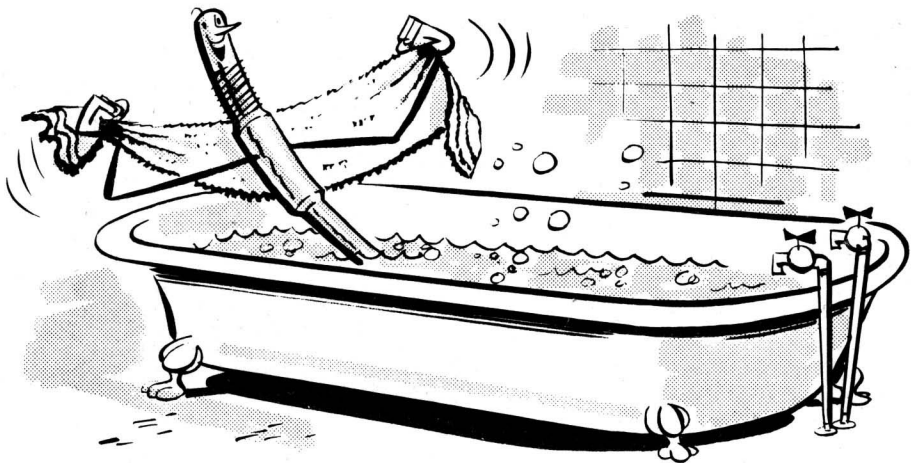
Test For Leaks. If you get a "come-back" "O" ring replacement job, you may find that the "O" ring previously installed was damaged during installation. "O" rings can be nicked or sheared if there's a rough edge or burr on the valve operating rod, or on the upper and

lower piston rods. Always check a ring groove carefully for this roughness.

If you notice roughness, always use emery cloth or a fine file to dress it down before installing a new seal. Lubricant applied to the "O" ring will not only let you roll it into place easily, but will also help protect the seal from damage.

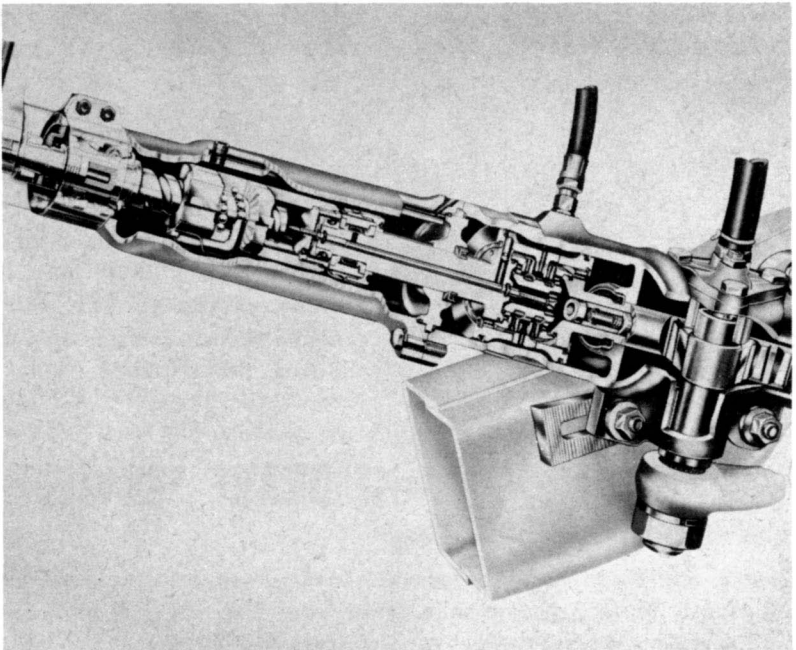
Now, while the power unit is pressurized, if high pressure leaks are present, you'll notice them at one of the following locations:

- (1) At the upper piston rod, indicating that this seal is in need of replacement.
- (2) At the upper end of the valve rod, which means the "O" ring seal in the upper end of the upper piston needs replacement.
- (3) At the reaction seal retainer, which points to replacing the reaction control seal.
- (4) At the housing cylinder head, which may show up a fine crack due to incorrect disassembly procedure or a casting that's become porous.

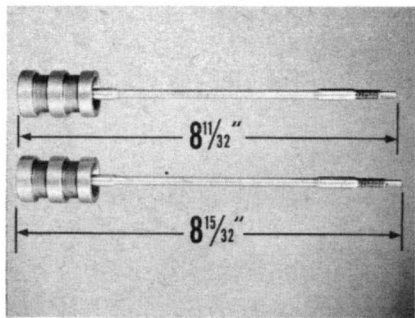
Check Valve Rod Length—Two different valve rods have been used in Coaxial Power Steering units. If you discover that the "O" ring

has been *forced out of its groove* at the upper end of the upper piston rod, chances are that the valve rod is too short. So, *check the length* of the rod. The short rod is $8\frac{11}{32}''$; the long rod is $8\frac{15}{32}''$ long. If necessary, replace the piston valve and rod assembly to correct this condition.

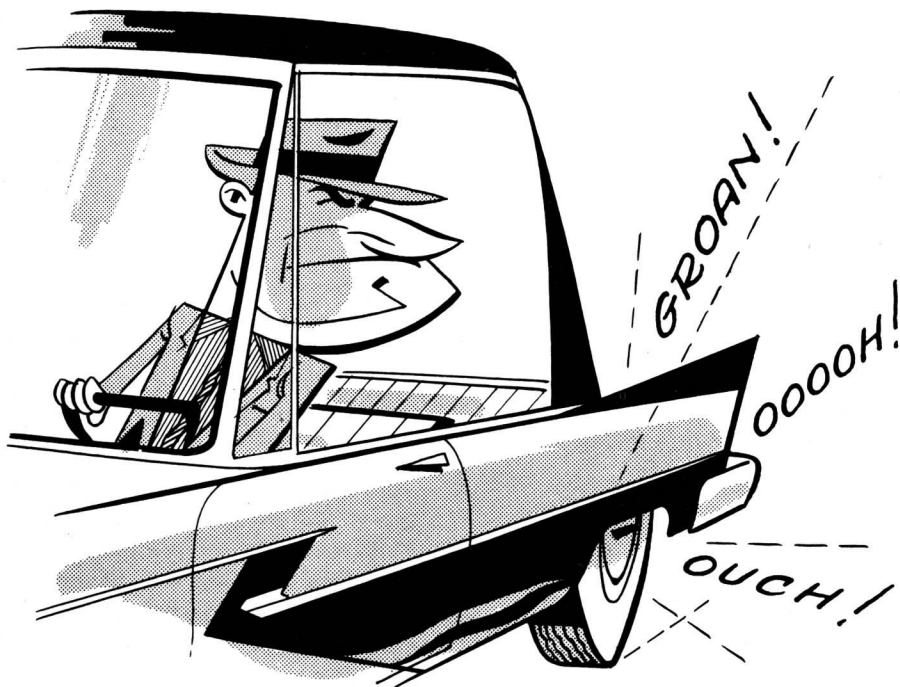
Rear Brake Noise (Chrysler and De Soto)—If an owner reports an occasional *howling* or *groaning* noise from the rear Center-Plane brakes, there's a definite checking procedure to follow.

First, see that the rear spring U-bolt nuts are tightened to a torque of 65 to 80 foot-pounds. This will eliminate any possibility of the axle moving on the springs.
