POWER STEERING and CARBURETOR SERVICE

PREPARED BY CHRYSLER CORPORATION
Plymouth • Dodge • De Soto • Chrysler • Imperial

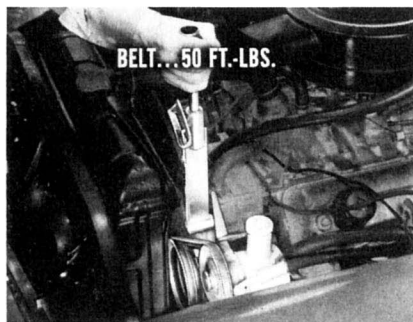
If fluid level is up to the mark, then check the pump belt. It should be free from oil and grease. And on the current Plymouth model, for example, the belt should be tightened to 50 foot-pounds torque. All belts, by the way, should be tightened at the regular inspection period — 1,000- or 2,000-mile — depending on the model.

If you use the torque method of tightening the belt, loosen the mounting bracket bolts, and apply the specified torque to the bracket. Then, tighten all bolts while torque is applied.

If you use the belt deflection method of checking tension, use Scale C-690 to establish the 5-lb. load on the belt when measuring deflection. (Use this method only when the torque method isn't possible, as it isn't quite as accurate as the torque method.) Belt tension specifications are listed in the table on the next page.

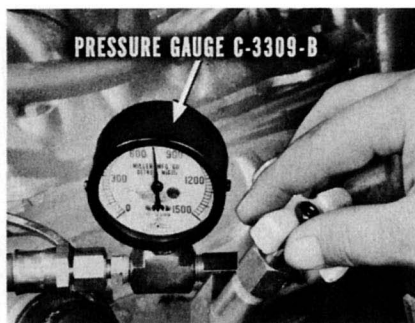
If belt tension is up to specifications, and is free from oil or grease, install Pressure Gauge C-3309-B. See if pump maximum pressure is up to specifications. As these pressures vary for different models, consult the table below.

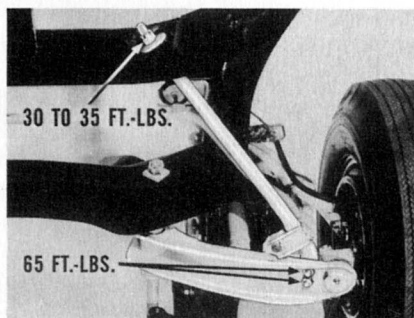
Loose lower control arm struts can also cause chuckle. Rear mounting bolt nuts should have 65 foot-pounds torque. The forward nut should be tightened to a torque of 30 to 35 foot-pounds.

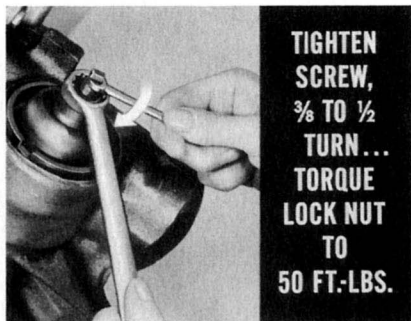
Adjusting the Cross-Shaft. To check the cross-shaft adjustment, you first center the steering wheel, with the front wheels straight ahead. Disconnect the center link. Then, with the engine running so you get the right feel of the mesh, loosen the adjusting screw lock nut and turn the screw *out* until you can feel a little backlash while moving the steering arm back and forth by hand. Next, turn the screw *in*, until backlash disappears.

Finally, turn the adjusting screw *in* $\frac{3}{8}$ to $\frac{1}{2}$ turn. Torque the lock nut to 50 foot-pounds, and you're done.

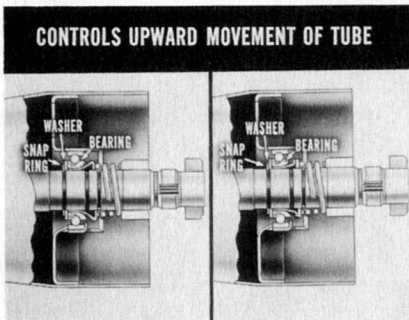
Now, if returnability is still poor after you relocate the jacket, remove the steering wheel and jacket. See if the spacer washer is assembled *under* the jacket bearing, or if the washer is missing. The washer, which is assembled between the snap ring and lower end of the jacket bearing, controls upward movement of the tube. It also maintains proper clearance between the steering wheel hub and top of the column.

NOTE: There should be only *one* washer below the bearing. Do not try to install additional washers. More than one washer will not only affect steering on a *left* turn, but can also completely hamper returnability on a *right* turn!

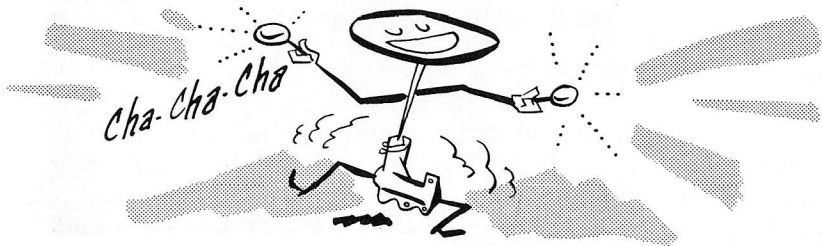
Excessive clearance between the connector pin and its slot in the tube may cause this noise. To correct this, remove the pin from the coupling and tube, and slip additional inserts (Part No. 1733769) between the tube and the insulator. This will hold the pin more securely in the slot. A new tube insulator of a different shape, and new plastic inserts are being used on current production units. A new tube with a revamped lower end is also used with the new type insulator.

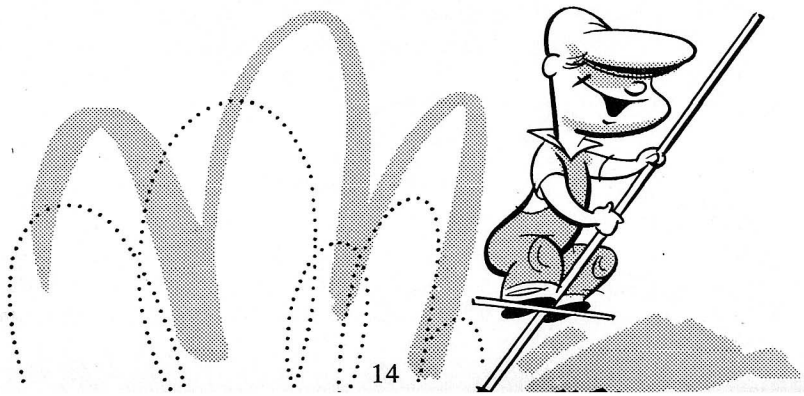
Some owners may report end play they notice when they push down on the steering wheel. While this movement varies from only $\frac{1}{16}$ " to $\frac{3}{16}$ " and is generally regarded normal, some customers may want it corrected. If so, you can install an additional spacer washer (Part No. 1828910) *above* the upper steering tube bearing. This will in-

crease pressure of the 60-pound spring above the bearing that's designed to work in conjunction with the normal friction in the coupling to resist axial movement. In all cases, be sure to insert this spacer *above* the bearing. Getting it below will restrict worm-shaft movement, and affect returnability.

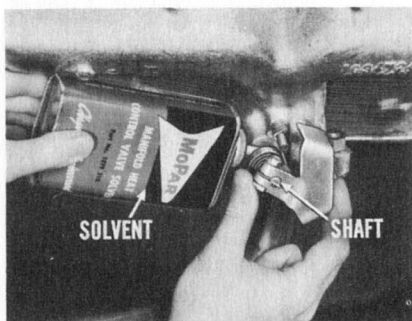
If you're working on a car where the engine stalls in neutral, or in gear, after a cold start, check the manifold heat control valve before you touch the carburetor. If the heat control valve sticks open, hot exhaust gases won't warm up the intake manifold so it can vaporize fuel properly. Engine warm-up will be poor, and it'll stall. This can even cause stumble on acceleration and poor fuel economy.

So, move the counterweight back and forth against the tension of its thermostatic coil. It should turn freely and return to the closed position. You can free up a sticking shaft with heat control valve solvent (Part No. 1879318). Be sure, though, that the valve is cool. Let the solvent soak in several minutes. Then, turn the shaft back and forth to loosen it up.

NOTE: If the shaft is stuck tightly, tap the ends of the shaft *lightly* with a hammer to break it loose (after solvent has been applied). Then rotate further to free it up.

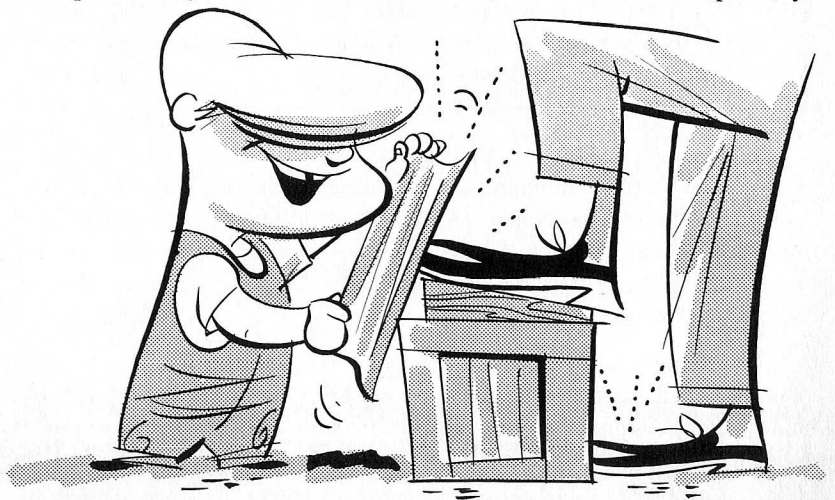
Check Throttle Valve Positioning. A difference in readings may call for repositioning of the throttle valves. Or, the throttle shaft (primary

shaft on 4-barrel units) may be binding in the body. Damaged throttle valves should be replaced. If the shaft is sticking, remove it and polish the rough area with crocus cloth. Be careful not to reduce the diameter, because this can cause an air leak that will upset the fuel-air mixture ratio.

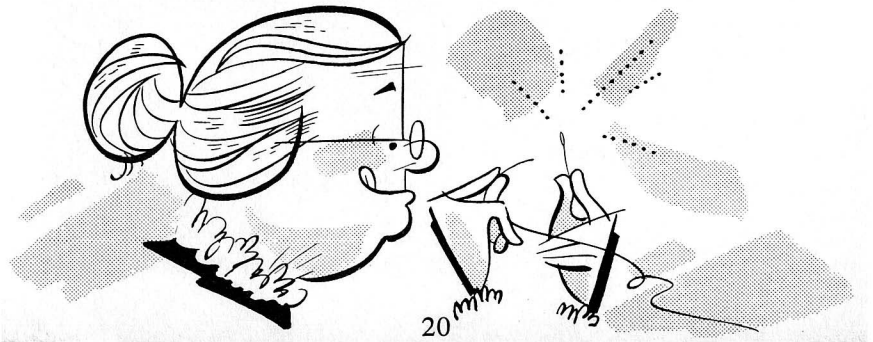
If you check ignition, timing, heat control valve operation, and fast-idle speed and find them all okay, engine stalling may be caused by improper choke operation. Chances are it's opening too much during the engine warm-up period. Sometimes you can change the length of the vacuum piston link and correct this condition. On the AFB and the BBD carburetors with the cross-over choke marked

AX, you can remove the cotter pin from the choke lever. Take a $\frac{1}{16}$ " diameter wire about $1\frac{3}{4}$ " long. Put one end through the two holes in the lever so it sticks out about $\frac{1}{8}$ " on the short end. Bend the long end of the wire around the bottom of the lever to form a "U" with uneven sides. Remove the wire.

Pass the long end through the hole in the link, and the short end through the holes in the lever. Hold the wire tightly against the lever and bend the long end behind the short end extension, and over the top of the lever. Installing this wire will reduce the amount of choke opening at idle and light load running during warm-up, and help to prevent stalling.

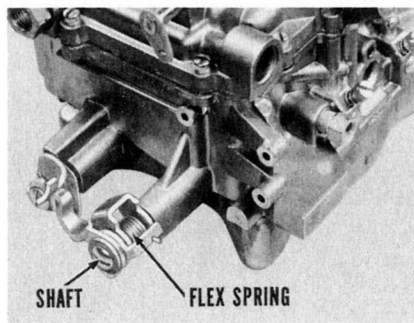
On models with the 350- or 361-cubic-inch engines and AFB four-barrel carburetors, you may get a report of a power surge on acceleration around 35 to 40 m.p.h. Since this takes place when the secondary throttle valves should gradually open, their *sudden* opening can cause the instant surge of power.

So check the secondary throttle valve shaft for binding. Also, check the throttle valves for damage or improper positioning that would prevent their gradual opening. Besides that, check the throttle flex spring on the right end of the primary throttle shaft. It may not be

strong enough to overcome any slight sticking or resistance on the part of the throttle valve assembly. You can check this by removing the air cleaner and observing throttle opening. If valves are positioned properly, and the shaft doesn't bind, install a new, stronger flex spring (Carter No. 61-623).
