ENGINE SERVICE TIPS

Prepared by CHRYSLER CORPORATION

PLYMOUTH, DODGE, CHRYSLER-IMPERIAL DIVISIONS

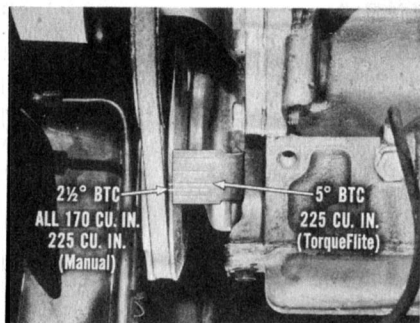
Upon receiving a report of detonation, or loss of power, road-test the car first to verify the exact condition. Also, find out which grade of fuel the owner normally uses. Detonation, remember, is usually caused by low-octane fuel or incorrect ignition timing. It can also be caused by using spark plugs of the incorrect heat range, localized hot spots or engine overheating caused by some obstruction in the cooling system.

Ignition timing is set at $2\frac{1}{2}^{\circ}$ BTC on all 170-cubic-inch engines (Valiant and Lancer), and on the 225-cubic-inch engines used with manual transmissions. Set ignition timing at 5° BTC on the 225-cubic-inch engine used with the TorqueFlite automatic transmissions.

After setting ignition timing with a timing light, test the car on the road to see that it is delivering the best engine performance for the fuel being used. If it was necessary to change the timing from the basic specification during the road test, to eliminate detonation or to improve performance, determine the final setting by testing it with a timing light after returning to the shop.

Don't *retard* timing more than 5° from the specified setting. On the other hand, see that timing is never *advanced* more than 5° from the specified setting. Too much advance can cause pre-ignition, burned pistons, or other serious damage.

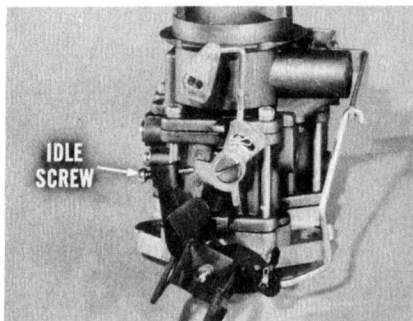
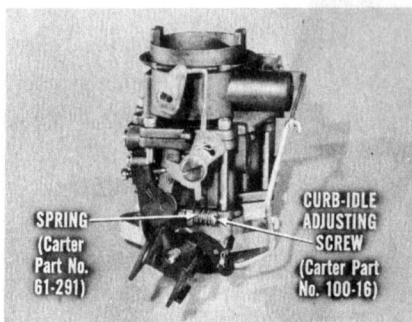
Adjusting fast idle and curb idle on early 1960 model six-cylinder engines is occasionally a problem. That's because the carburetor has only one screw for setting both the fast and curb idle. With this setup, fast idle may be too fast when curb idle is okay. And, when fast idle is okay, the curb idle may be too slow and cause a rough idle or stalling.

In a case of this kind, install a curb-idle adjusting screw (Carter Part No. 100-16) and spring (Carter Part No. 61-291) in the tapped hole provided. This will permit accurate curb-idle setting independently of fast-idle setting, and result in improved engine performance.

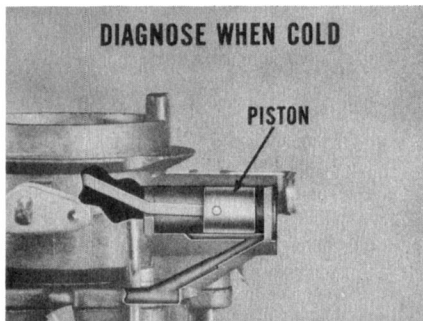
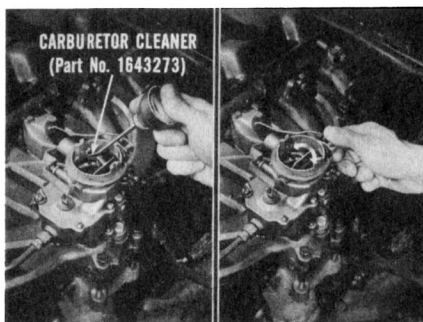
Occasionally, there are reports of poor cold starting. This might be caused by improper choke valve action due to gum deposits which cause the choke vacuum unloader piston to stick. It can occur on all carburetor models, including 1960, which have the vacuum piston cylinder as an integral part of the air horn.

diagnosis can be made only at that time. When the engine's at normal operating temperature, the gum deposits liquefy and allow movement of the piston. However, upon cooling, the gum solidifies to act as an adhesive between the piston and cylinder.

This adhesion, in most cases, is not strong. You can free the piston with a slight pressure, but the sticking will re-occur with each cooling cycle.

Certain fuels and fuel additives contribute to this gum formation. In addition, low-speed and stop-and-go driving during cold weather aggravate the condition.

As a good preventive maintenance practice whenever the air cleaner is removed for service, squirt a few drops of carburetor cleaner (Part No. 164-3273) into the vacuum piston chamber, while the engine is idling. Move the choke valve back and forth to help the cleaner flush the deposits from the piston and bore.

As gum deposits accumulate throughout the carburetor, a complete cleaning will be needed—especially at the choke shaft bearings. On every major job, remove the welch plug from the end of the cylinder, and remove the piston and link assembly. Dip the piston in cleaning solvent and insert the piston into its cylinder. Work the piston in the cylinder to help dissolve deposits. Clean the cylinder with compressed air or a clean cloth, and dry the piston.

Reinstall the piston assembly, connect it to the choke valve and install a new welch plug, Carter Carburetor Part No. 47-30 ($\frac{5}{8}$ " diameter), or Stromberg Carburetor Part No. 388116 ($\frac{3}{4}$ " diameter) in the end of the cylinder. Inspect the choke system for freedom of operation and proper adjustment.

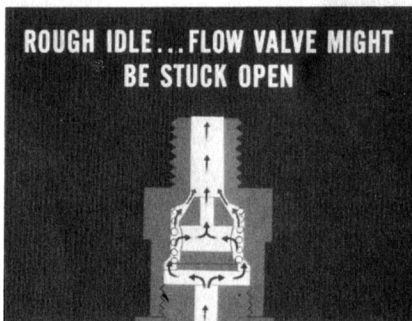
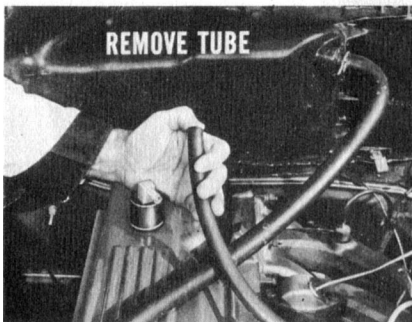
On an engine equipped with the closed crankcase ventilation system, engine idle will be rough and the engine will have a tendency to stall if the flow valve sticks in its open position. This would let excess air bleed in at idle, and lean out the fuel mixture.

A quick test for a sticking flow valve is to remove the flexible connecting hose from the flow valve and hold your thumb over the end of the hose. If engine idle smooths out, the flow valve is probably dirty and needs cleaning.

The flow valve should be serviced regularly, of course. This is particularly important on cars that are operated under short-trip driving conditions during cold weather.

If the flow valve happens to be clean, test for other causes of rough idle and stalling. In short, inspect for vacuum line leaks, a loose intake manifold, or valve lash that just might be too tight.

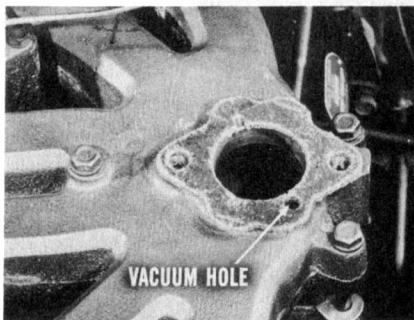
It's also smart to inspect gasket installation between the carburetor and manifold on all 1961 cars with 6-cylinder engines. The gasket must be installed so that the vacuum hole in the gasket indexes with the hole provided in the manifold for the closed crankcase ventilation

system. If the gasket is incorrectly positioned, it might block the

choke piston and the step-up piston vacuum ports. And if the vacuum hole in the gasket is not positioned at the hole in the manifold, there will be a rough engine idle. The vacuum hole must line up with the manifold hole provided, or an air leak will result.

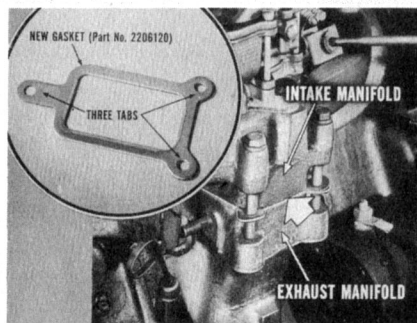
There may be occasional reports of a snapping, popping sound as

the six-cylinder engine cools. It's caused by relative movement of the manifolds at the intake-to-exhaust-manifold gasket, when the exhaust manifold contracts. This movement might even cause the gasket to creep. To prevent this noise, apply MoPar "Led-Plate" (Part No. 2275437) to each side of the gasket.

A new intake-to-exhaust-manifold gasket (Part No. 2206120) is available. It has three anchoring tabs. Use the new gasket whenever replacement is necessary, and remember to apply "Led-Plate" to each side of the gasket to prevent noise.

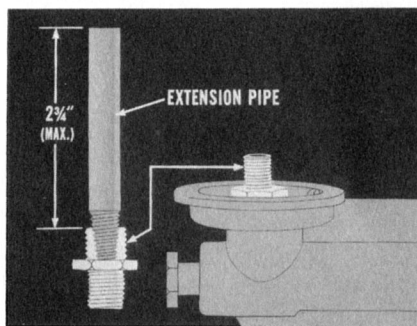
Some 6-cylinder engines may have a noise that sounds like a bearing rumble when the car is first started in cold weather. The noise goes away as soon as oil pressure builds up. This condition is generally caused by oil draining from the filter through the bearings while the engine was not running.

In a case like this, make an oil filter extension pipe out of $\frac{1}{4}$ " pipe. Install this extension to provide an oil reservoir for an added oil supply during initial engine starting. Here are the detailed steps to follow for this operation:

1. Remove the oil filter from the engine oil pump.

2. Use a 1" socket wrench to remove the filter mounting adapter coupling from the pump body.
3. Use a 1/4" standard pipe tap to tap the filter adapter coupling I.D. at the upper end to a depth of 1/2".
4. Make the extension pipe from standard iron pipe 1/4" x 4" (unfinished length). Use a 1/4" pipe die to thread 3/4" at one end of the pipe.

NOTE: The extension pipe can also be made from a standard 1/4" x 4" threaded pipe nipple available at most hardware stores.

5. Securely screw the extension pipe into the tapped end of the adapter coupling. Measure from the upper end of the adapter to the end of the extension and cut the pipe to an exact length of 2 3/4". This will avoid interference with the oil filter bypass valve.
6. Install the filter adapter coupling and extension pipe in the oil pump body and tighten it securely. Finally, install the oil filter.

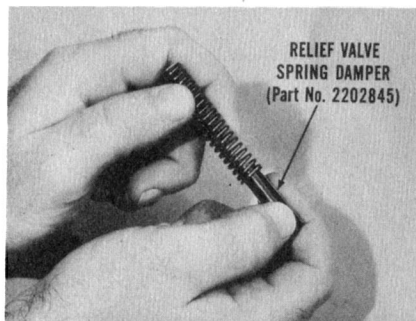
Another noise condition might turn up on some 1959 and 1960 cars equipped with the 361-, 383-, or 413-cubic-inch engines. It's a growling, grinding or buzzing sound heard most clearly at the oil pan. You can eliminate this particular noise by installing the new-type oil pump relief valve spring damper (Part No. 2202845).

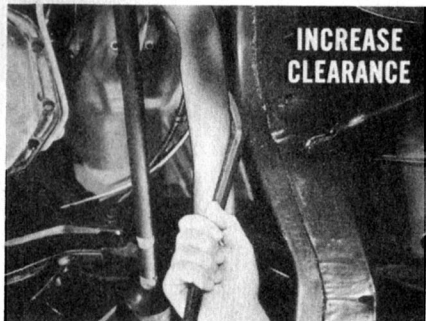
On 6-cylinder engines there is a sound that can be confused with a main bearing knock. It usually comes in when the car is accelerated under load. It's caused by the exhaust pipe hitting the frame side member—or any other part of the frame—as engine torque moves the engine on its flexible mountings. A bright spot on the exhaust pipe—where it makes contact—is the important clue. If you find the spot, use a torch to heat the exhaust pipe, and then bend the pipe to get increased clearance.

CAUTION: Don't bend the pipe too much or you'll kink it. Above all, don't try to bend the pipe *cold*, or you'll break the exhaust manifold flange.

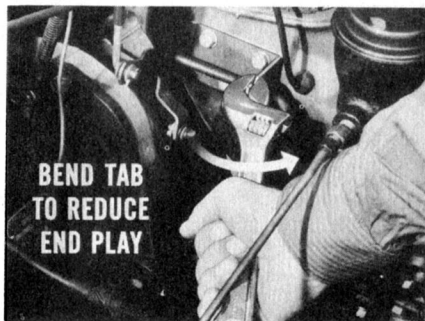
Some owners of 1960 and early 1961 cars have asked for correction of an accelerator linkage rattle. The cause in this case, has usually been traced to excessive end play of the accelerator bell crank in the dash-mounted bracket. About the simplest fix is to bend the shaft support tab on the left end of the bracket to reduce the amount of bell crank end play.

CAUTION: Don't bend the support bracket too much, or it will cause the linkage to bind. A slight amount of end play should remain.

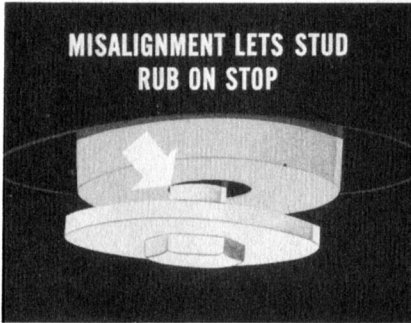
The engine spring-type rear mount may occasionally produce a harsh squawking sound. This condition can be determined by putting the car

on a hoist. Then, grasp the propeller shaft near the transmission and move it up and down to see if it will bring in the noise. A squawk of this type is generally caused by misalignment of the engine mounts that lets the rear mount stud rub on the rubber stop.

To correct the condition, loosen the front engine mounts. Shift the engine until the stud is centered in the rubber stop. Tighten the front mounts to specifications. Then, recheck for elimination of the squawk.

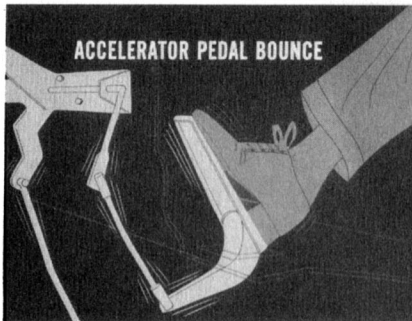
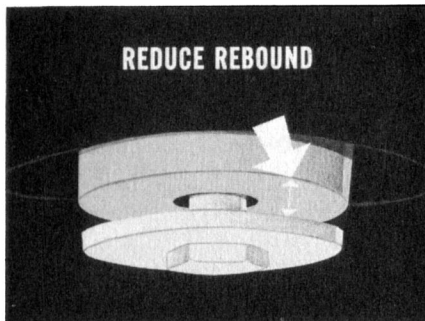
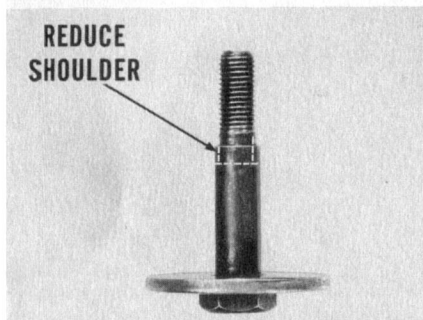
Under certain driving conditions, engine movement may cause an accelerator pedal bounce that the owner can feel through the sole of his shoe. If this pedal movement is objectionable after the engine has been properly tuned, the amount of rebound at the rear engine mount can be reduced.

In this instance, carefully measure the space between the lower stud washer and the rubber stop. This is the distance the engine can move upward on rebound, and it's usually about $\frac{1}{4}$ ". This measured space can be eliminated. On 1960 cars, the crossmember must be removed, but most 1961 models have the stud nut welded in place.

Remove the stud and turn it on a lathe to reduce shoulder height an amount equal to the measured space between the stud washer and stop.

NOTE: Don't replace the stud with a plain bolt. This can compress the spring fully and cause misalignment between the engine and drive line.

An alternate fix is to add just enough shims between the stud washer and rubber stop to fill in the rebound gap. But use just enough shims to fill the space or you'll change the drive-line angle.

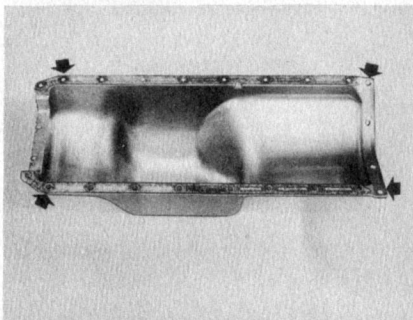
Unless the engine is jacked up and blocked that way, you won't have the working room needed – and you're apt to bend the oil pan corners. Bent corners on the pan won't seal properly and may cause an oil leak.

The instructions for jacking up and blocking the engine are of special importance. Be sure to use a block of wood positioned under the forward end of the oil pan (over the bolt heads), and then raise the front end of the engine about 2" with a jack against the wood block.

Once the engine is raised, place short pieces of 2" x 4" wood blocks between the engine supports and the "K" member. Then, lower the engine and remove the jack.

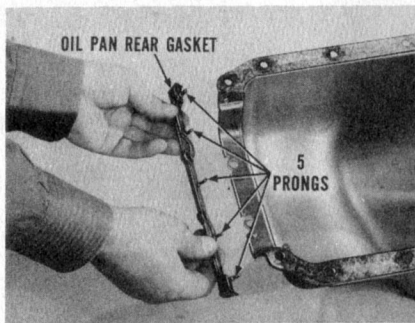
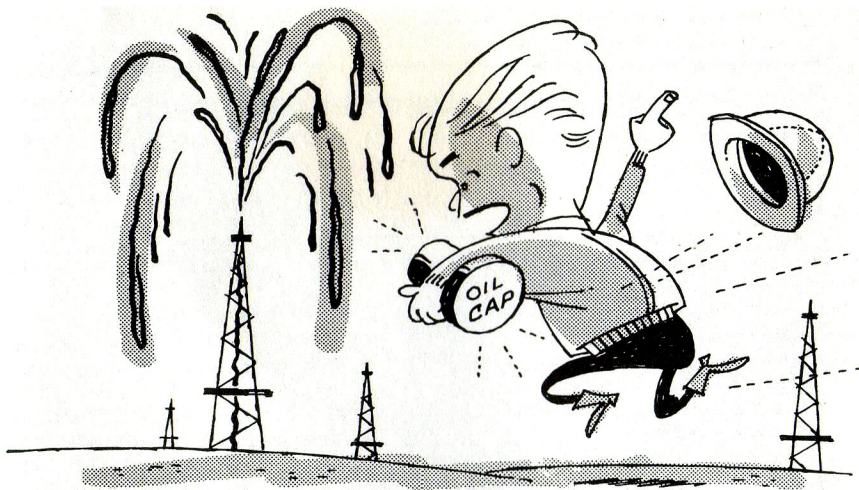
The oil pan rear gasket on the 6-cylinder engine has been changed. There are now *five* rubber prongs for better gasket positioning. Oil pans made since this change took place also have *five* holes.

When installing the new gasket on an earlier-type pan, don't be tempted to snip off any of the prongs to make the new gasket fit. Cutting off a rubber prong can cause the gasket to shift and spoil its sealing efficiency. Instead, adapt the pan to fit the new gasket.

Drill three new $\frac{5}{32}$ " holes in the oil pan flange. Just follow the drilling template and instruction sheet that comes with each new gasket package. And don't forget to inspect all pan attaching bolt holes to be sure they haven't been upset at their edges from over-tightening of the pan cap screws. Upset hole edges can lead to oil leaks. Flatten the holes if they have been upset.

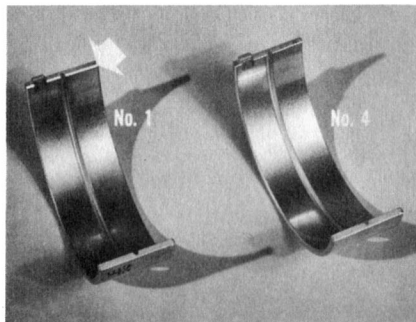
An oil leak at the rear crankshaft seal can occur if the number one and number four upper main bearing inserts have been interchanged. They can be installed that way, but the number one upper main bearing insert has a greater chamfer on the inside edge at the locating tab end to provide lubrication to the timing chain and sprockets. Putting this chamfered insert in the number four position will direct more oil against the rear main seal than it can handle.

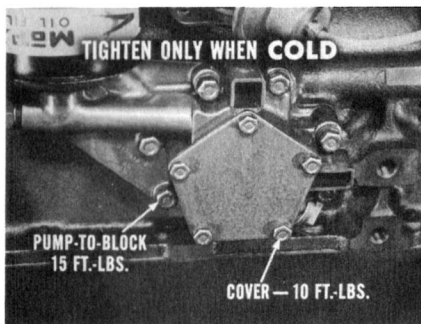
Leaks at this point can take place if the pump-to-block cap screws are too long and bottom in the holes. You can install flat washers under each screw, or cut one or two threads off each screw in order to compress the gasket enough to correct a leak.

It's also a mighty good idea to install a *new* pump-to-block gasket. The old gasket may have taken a set—or have an established leak path. And after you install the new gasket, tighten the pump-to-block cap screws evenly to 15 foot-pounds torque. Tighten the cover cap screws to 10 foot-pounds torque.

CAUTION: Remember . . . tighten oil pump cap screws *only when cold!* The aluminum and steel mating parts expand and contract at different rates.

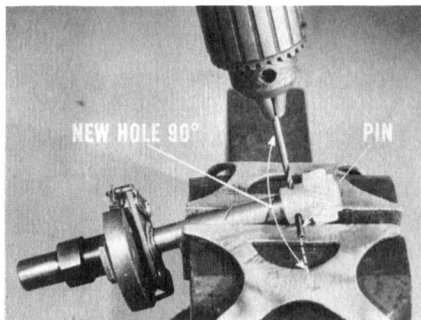
Oil leakage from the distributor housing vent holes may be caused by the gear retaining pin hole having been drilled through the spiral groove on the distributor shaft. The pin in the groove would naturally prevent reverse wiping of the oil and it would pile up instead.

In a case like this, position the gear on the shaft with the pin inserted just far enough to hold the original location. Drill a new hole 90° from that location, and install the pin in the new hole.

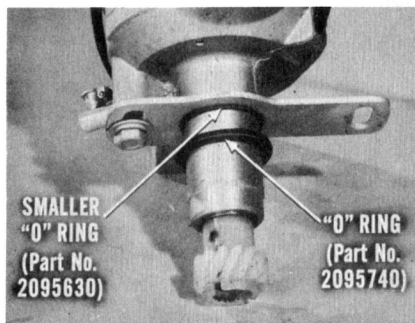
If there's an oil leak between the distributor and block, remove the distributor. If you find a cork gasket used, replace it with the newer, large "O" ring (Part No. 2095740).

If the distributor already has a large "O" ring and is leaking, remove and discard this "O" ring. Slide a smaller "O" ring (Part No. 2095630) into the small undercut under the retainer plate. Then, install a new, large-size "O" ring (Part No. 2095740). Reinstall the distributor and set ignition timing to specifications.
