SERVICE REFERENCE BOOK

of the MASTER TECHNICIANS SERVICE CONFERENCE

159

Steering and Suspension Service Tips

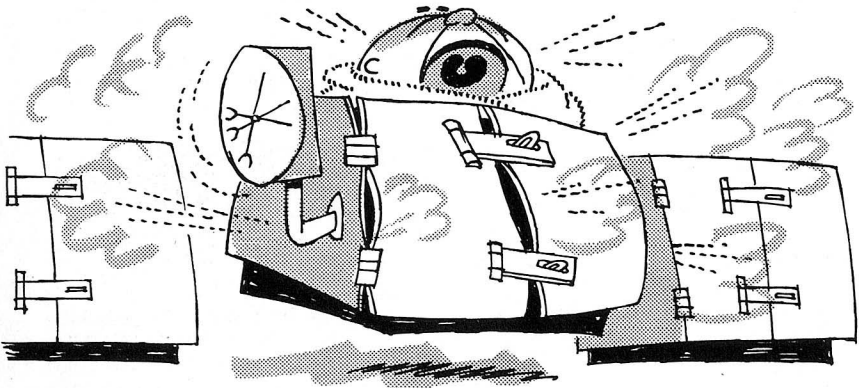
If the pressure rises to more than the maximum indicated on the chart, the relief valve is not opening when it should. It is also possible, in all models except Imperial, that a higher value pressure-relief valve has been installed in the pump.

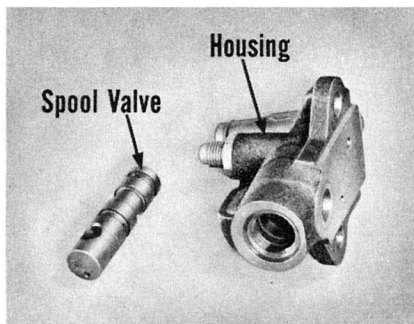
If the spool valve sticks in the housing bore, remove and examine the valve and bore for nicks, burrs and score marks.

Minor imperfections, if found on the valve and in the bore, can usually be removed by polishing with crocus cloth. Be careful not to round off the edges on the spool or bore. If the valve is too badly damaged, replace the valve *and* the housing, since these parts are supplied as a fitted assembly.

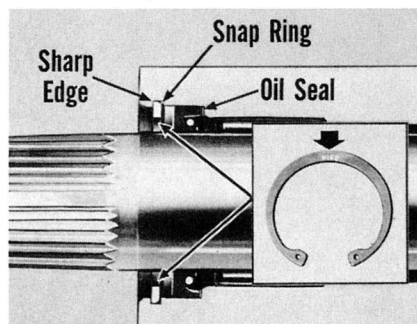
Oil Leak—Cross Shaft Oil Seal Snap Ring. There have been occasional reports of an oil leak at the lower end of the steering gear cross shaft on models equipped with power steering. When investigating a report of this nature, carefully note the position of the oil seal snap ring. If the ring is not properly in place in its groove in the gear housing, it is likely the ring was installed with the side with the sharp edge facing *inward* instead of *outward*. When installed in this manner, the ring may snap out of the groove.

To provide a better seal at this point, on cars other than Valiant and Lancer, a new improved snap ring was recently released for use in both production and service. It is identified by the number W-168, stamped on the side with the *sharp* edge.

This new ring should be used exclusively in service, whenever there is an occasion to disassemble the steering gear or replace the cross shaft oil seal on all cars except Valiant and Lancer. When installing the ring, be sure the side with the number and sharp edge

is facing *outward*, toward the steering arm. In this way the ring will seat firmly in its groove and there is no possibility of it popping out and causing an oil leak.

Do not reinstall the old snap ring. Always use a new one, and be sure the side with the sharp edge is facing outward.

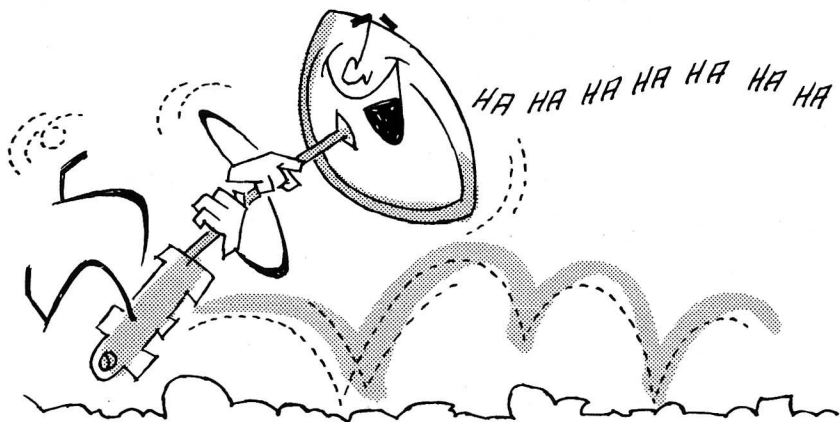
Chuckling Noise. There may be reports of a chuckling noise in the steering gear of a car equipped with power steering, when driving over railroad tracks or rough roads. The first item to examine would be the cross shaft adjustment. If the adjustment is satisfactory, or an adjustment does not afford relief, it is possible there is looseness in the steering gear coupling.

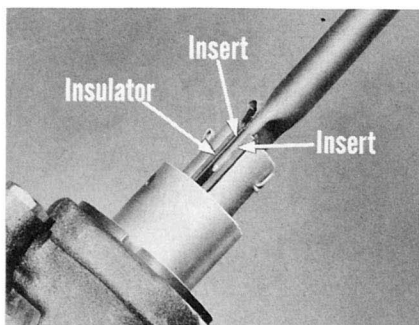
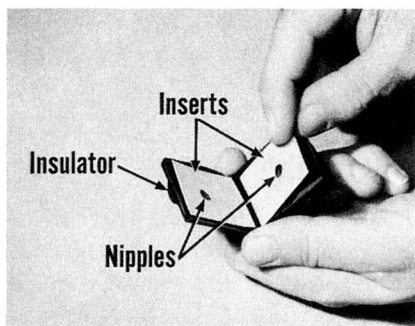
Looseness at this point can be determined by rocking the steering wheel and shaft in the housing. If there appears to be excessive movement, it is possible the rubber insulator and the plastic inserts in the insulator are damaged, or the insulator is undersize.

To correct this condition, remove the steering gear shaft and coupling from the gear. When installing new parts, be sure one insert is assembled on each side of the rubber insulator, and that the nipples on the insulator pass through the holes in the inserts to hold them in position in the insulator.

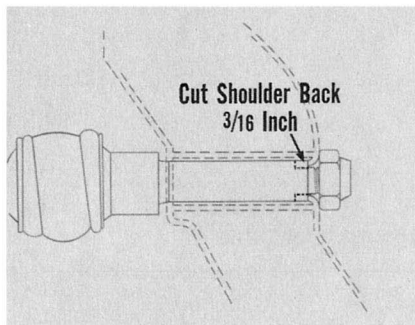
On some early production models, the customer might report a noisy rear shock absorber condition. Investigation has disclosed that the noise, while appearing to originate in the shock absorbers, is actually in the upper mounting. Interference between the shoulder on the mounting stud and the body sheet metal prevents proper tightening of the stud nut.

The interference can be eliminated by removing the stud and reducing the length of the shoulder 3/16 of an inch. This will permit the stud to be drawn up until it seats against the mounting bracket.
