**service reference book
session no. 105**

POWERFLITE,

POWER STEERING

BRAKE SERVICE

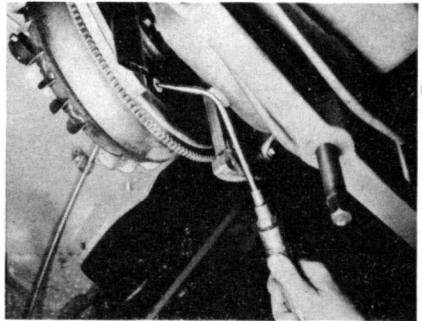
Usually, you'll heat a spot about 1/2" in diameter until it is a dull red. Next, quench the area quickly with wet rags to shrink the hub back into line. Recheck hub runout with the dial indicator when the converter returns to a uniform room temperature.

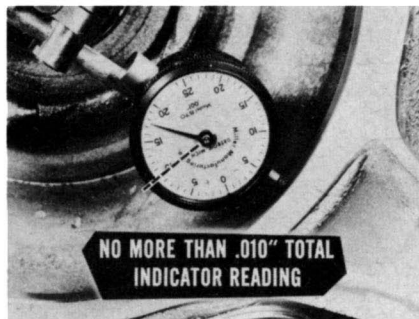
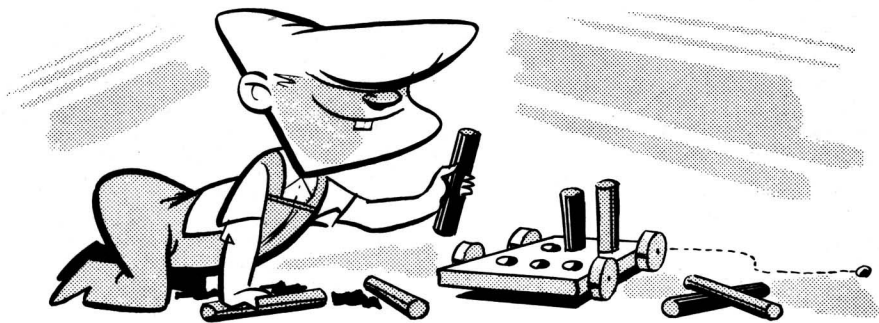
With a wrench, hold the flat end of the fixture bolt and tighten the nut. Then, mount the indicator on end of the bolt. Set the dial anvil so it bears on the transmission pilot bore of the converter housing. Then, turn the converter a full turn two or three times and take your readings. There should be no more than .010" total indicator reading. If it is more . . . say about .018" total reading, you'll have to shift the housing on the adapter plate in a direction opposite the point you noticed the maximum runout indication. Shifting the housing is done by first replacing the two steel dowels.

When selecting the new eccentric dowel to be used for a particular job, take the dowel closest to *one-half the total indicator reading*. For example:

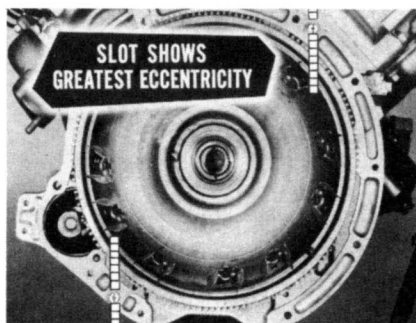
Here's another point to keep in mind. The position of the slot shows where the dowel has its greatest eccentricity. So, keep the dowel slots parallel, and the high side of the eccentric in the direction of the point where you noticed the minimum runout reading.

Make sure the mating surfaces of the plate and housing are free from nicks and dirt. Then, install the housing and torque the screws from 25 to 30 foot-pounds. Mount the indicator and check bore runout again.

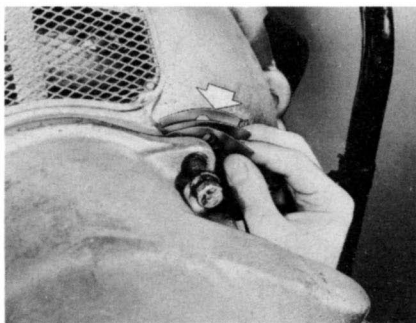
Face runout shouldn't be more than $.008$ ". Make a note of any low points because you'll be using shims there to square up the transmission.

What you do is slip shims over the bolt between the housing and transmission case. The thickness of shims you pick depends on the runout reading. For the correct location and shim thickness to use, refer to the following table.

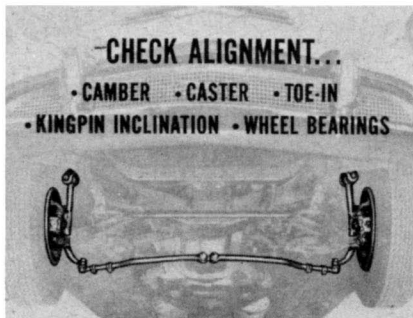
Check also for a bind or looseness at the idler arm. Besides that, look for loose or cocked tie rod ends . . . or loose steering knuckle arms. Tighten or replace any faulty parts.

Front wheel alignment, naturally, has to be right. So, check camber, caster, toe-in, kingpin inclination, and front wheel bearing adjustment. Get all these points up to specifications for the car you're working on.

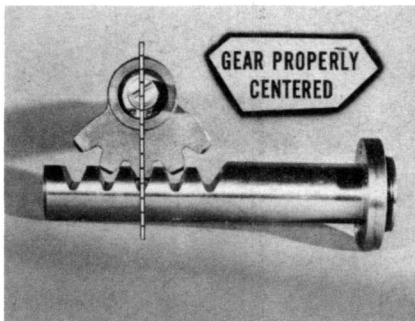
Check the gear shaft adjustment first. You can correct it by means of the adjusting screw. It moves the gear shaft teeth into closer mesh with the rack teeth on the lower piston rod.

Before you make that adjustment, however, make sure the steering gear is properly centered to the over-all travel of the gear. You can center the gear by turning the steering wheel from one extreme to the other. Count the number of turns. Then, bring the wheel back to the half-way point.

Once the gear is centered, turn the adjusting screw *out* until there's backlash at the steering arm. Next, slowly turn the screw *in* until there is *zero* backlash.

After that, turn the screw *in not more than 3/4ths turn* to preload the gear properly. Secure this position by tightening the lock nut. Finally, check free play at the steering wheel again. If it is gone, adjusting the gear shaft will probably correct the "wandering" condition.

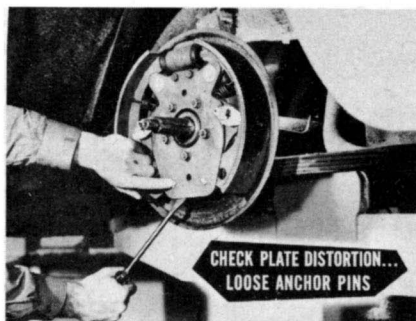
Next, inspect the support plates for distortion, and for loose anchor pins. Use a screwdriver between the plates while you press a finger against the end of the anchor pin to check looseness.

If the pins are loose, remove the support plate from the dust shield. Rest the pin on an anvil, and peen the end until the pin is tight. Be sure that both support plates are in good alignment.

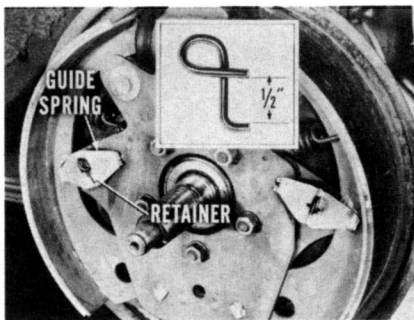
Check the two brake shoe guide springs. They hold the shoes steady, and cut down vibration, provided that they exert maximum tension against the shoe and support. Bend the springs to increase this tension, if necessary. Check the spring retainer, too; there should be about $\frac{1}{2}$ " between the two spring retainer prongs. Bend the prongs to get this distance, if needed.

Replace any warped shoes or support plates. Finally . . . button up the brake assemblies and road-test the job.

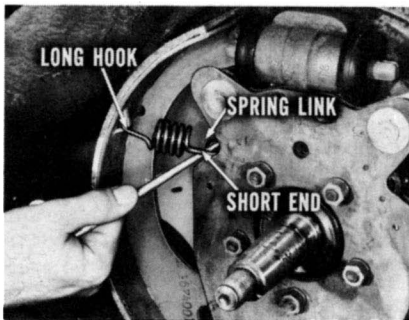
You'll notice that the new brake shoes have *loops* on their outside edges. The new, 5-coil return springs hook into those loops and provide the shoes with both a return force and side thrust.

Put the long hook of the return spring in the shoe, and the shorter end in the spring link. Next, install the original brake shoe guide springs and retainers. Install the wheel and drum, and road-test the job.
