POWER STEERING and CARBURETOR SERVICE

PREPARED BY CHRYSLER CORPORATION
Plymouth • Dodge • De Soto • Chrysler • Imperial

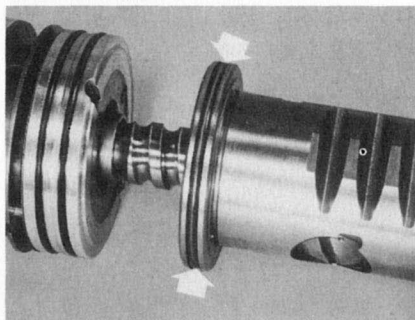
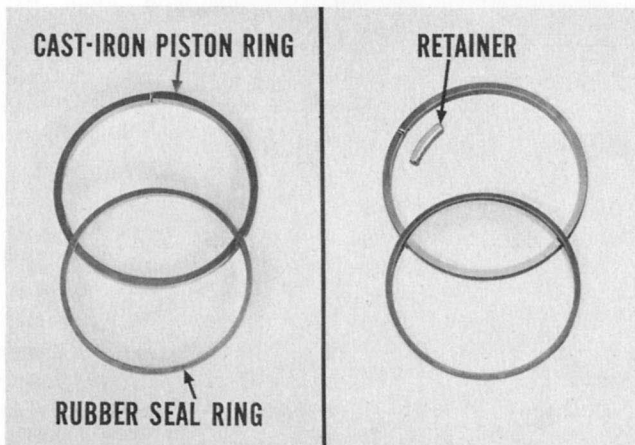
If you're working on an early production unit, you're apt to find that the power piston has a synthetic rubber "D" ring. The rounded edge of this "D" ring should extend above the piston flange. If it doesn't, it's been worn so much that it permits fluid to leak past the piston flange. That can cause lumpy power steering. In any case,

whenever you find a synthetic rubber "D" ring in a unit, replace it with the new cast-iron ring that is now available. The cast-iron ring makes a better seal, and seats in quicker, even if the piston bore surface is somewhat rough.

New Piston Ring Package. There are two cast-iron piston ring packages available for service, under Part No. 1879745. One package has the cast-iron ring and a synthetic rubber seal ring; the other contains the piston ring and seal ring, plus a retainer which fits on the piston ring to protect the seal ring.

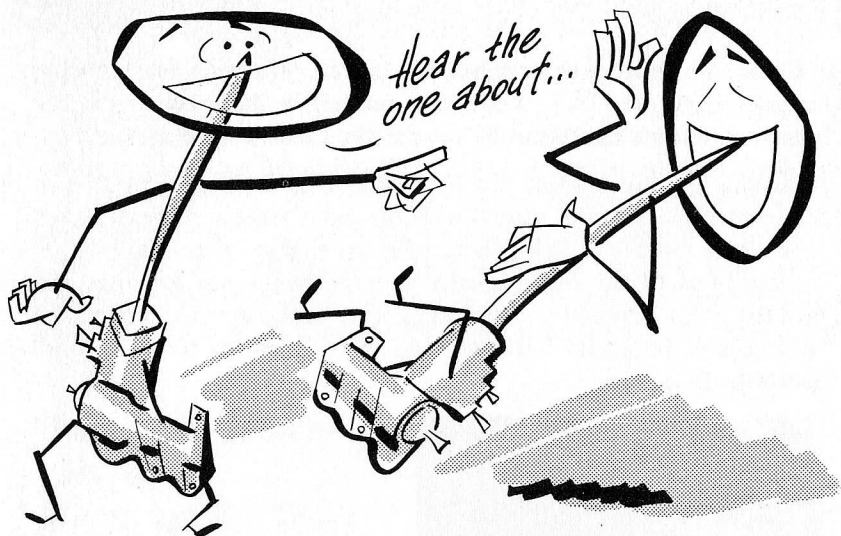
Once in a while you may get a report of a chuckling noise when driving over rough, choppy roads at speeds of 5 to 10 m.p.h. It's

annoying to some owners, and you may be asked to correct the condition.

As you probably know, certain clearances are necessary in a hydraulic gear. Therefore, some noise on really rough roads is normal. But if noise seems to be greater than standard, backlash between the cross-shaft and piston teeth might be excessive. The cross-shaft adjustment should always be checked at the 1,000- or 2,000-mile inspection period to take care of the slight wearing-in of new parts. It's a good thing to check when chuckle is reported.

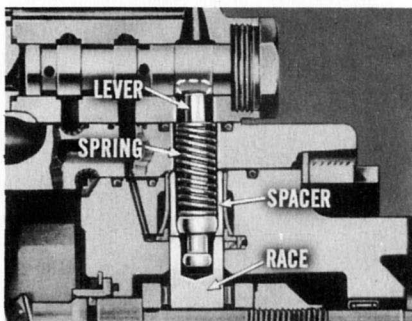
Spring-Loaded Pivot Valve Lever. Notice the letter stamped on the housing of any power unit you service. A unit stamped “J”, for example, has a new spring-loaded pivot valve lever, along with a new valve housing (Part No. 1822391). This refinement has improved returnability on turns.

The shank of the new valve lever (Part No. 1822380) has a smaller diameter. This permits installation of a coil spring (Part No. 1822383) which sits on a shoulder right above the lever’s spherical section. A spacer and race (Part Nos. 1822390, 1822381, 1822384), also new, go with the valve lever. Spring pressure holds the lever more firmly seated in the spacer. As a result, friction in the valve centering system is reduced, and returnability is improved.

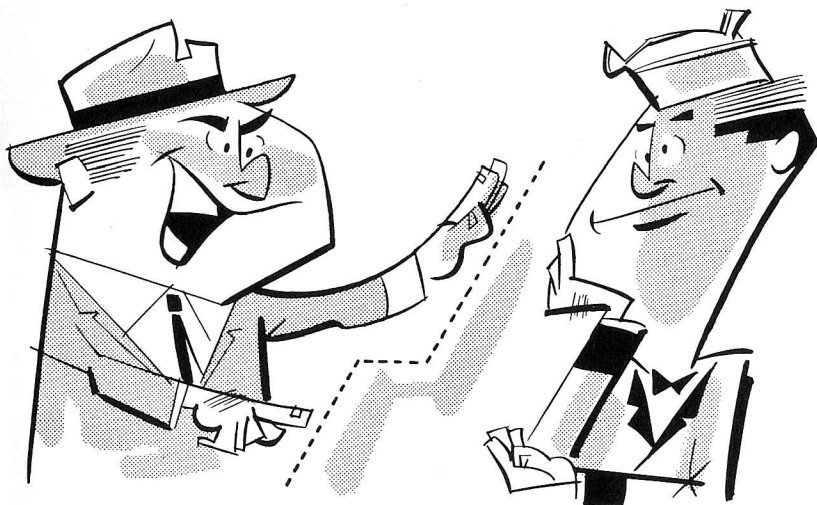
If an owner reports this condition, after warm-up, during speeds just above 20 m.p.h., check compression, ignition, and timing first. If they're okay, the fuel-air mixture is probably too lean. On Plymouth

with the BBD carburetor, you'd install a stronger, pink-colored step-up piston spring (Carter No. 61-549). And, on cars with manual and overdrive transmissions, install richer step-up wires .020" diameter (Carter No. 75-1217, Chrysler Part No. 1631613), in place of the standard .022" wire (Carter No. 75-1140).

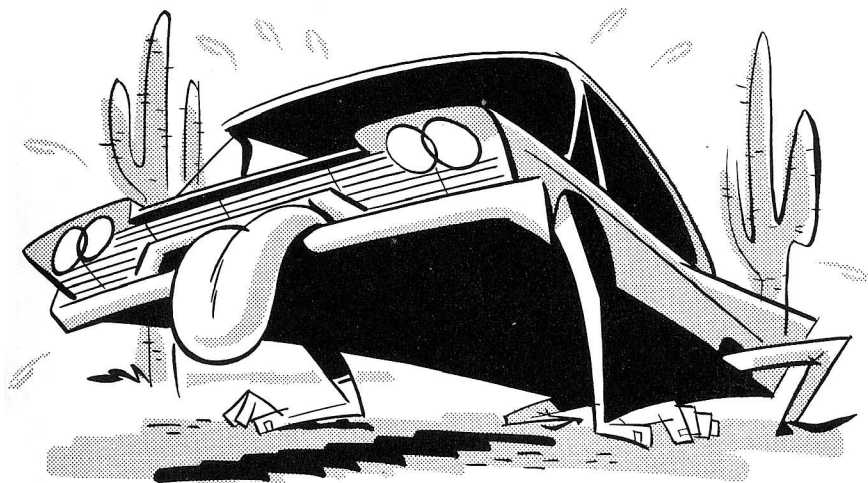
Fuel starvation may be reported during fixed throttle operation at higher speeds, or on full throttle acceleration. This condition may also occur at lower speeds as the car accumulates mileage. Frequently the condition is caused by a clogged fuel filter element. However, an incorrect float level or low fuel pump pressure can also cause starva-

tion. You can make a quick check by removing the element from the filter and driving the car at the speeds at which the condition was reported by the owner. If the engine runs satisfactorily, the filter was clogged and responsible. Clogged filters can't be cleaned very well, so install a new one. If a new filter doesn't show improvement, check the float level and fuel pump pressure.

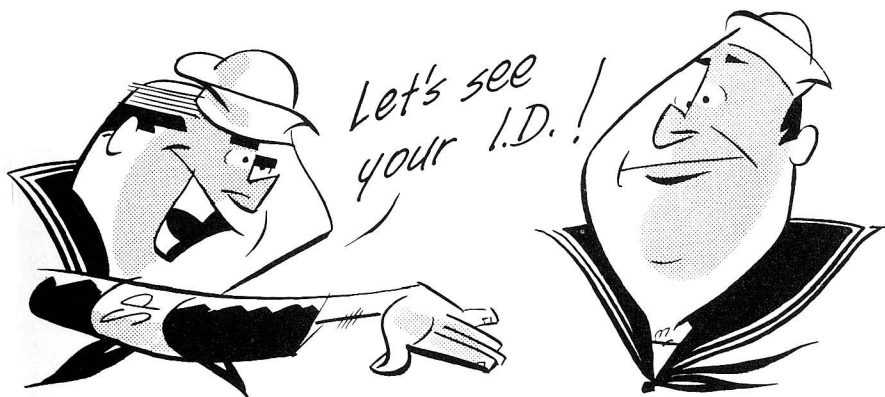
SURE-GRIP DIFFERENTIAL IDENTIFICATION

Sure-Grip differentials are identified by a letter "S" stamped on the pad next to the filler plug hole in the carrier. On some models, an aluminum tag at one of the carrier bolt nuts serves as Sure-Grip identification.

If you wish to make even more positive identification, raise the car and remove the filler plug. With a flashlight, sight through the plug hole. Look upward, to the left, and you will see differential case boltheads and the dome-like cylindrical shape of the case. Window openings of the case are also a Sure-Grip feature.
