ENGINE SERVICE TIPS

Prepared by CHRYSLER CORPORATION

PLYMOUTH, DODGE, CHRYSLER-IMPERIAL DIVISIONS

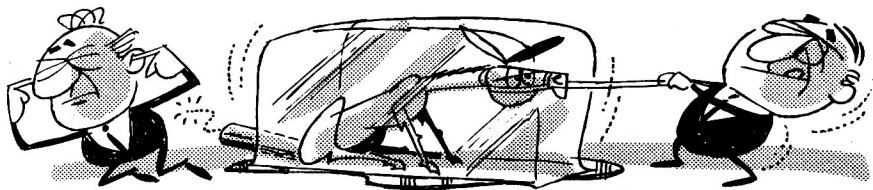
Occasionally, there are reports of poor cold starting. This might be caused by improper choke valve action due to gum deposits which cause the choke vacuum unloader piston to stick. It can occur on all carburetor models, including 1960, which have the vacuum piston cylinder as an integral part of the air horn.

diagnosis can be made only at that time. When the engine's at normal operating temperature, the gum deposits liquefy and allow movement of the piston. However, upon cooling, the gum solidifies to act as an adhesive between the piston and cylinder.

This adhesion, in most cases, is not strong. You can free the piston with a slight pressure, but the sticking will re-occur with each cooling cycle.

Certain fuels and fuel additives contribute to this gum formation. In addition, low-speed and stop-and-go driving during cold weather aggravate the condition.

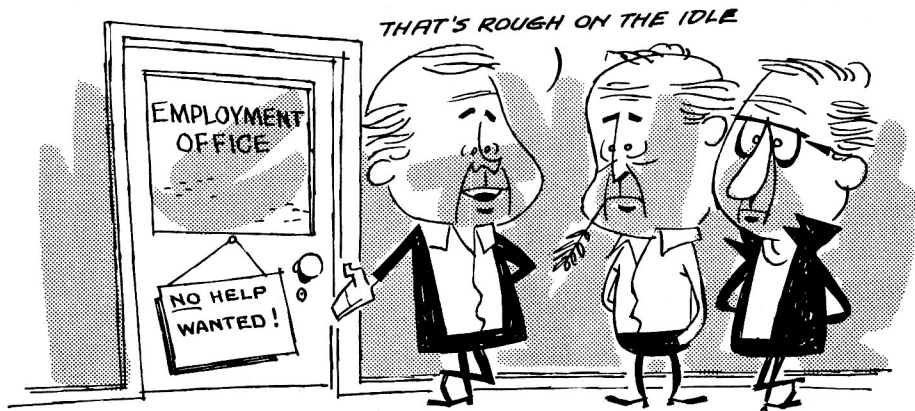
If the flow valve happens to be clean, test for other causes of rough idle and stalling. In short, inspect for vacuum line leaks, a loose intake manifold, or valve lash that just might be too tight.

NOTE: All V-8 engines equipped with 4-barrel carburetors and the high-performance camshaft, and fitted with closed crankcase ventilation, require a flow valve with a lower spring rate. That's because engine vacuum at idle is lower on these engines. The standard flow valve spring might not allow engine vacuum to close the valve. So, don't interchange flow valves without double-checking part numbers. For the high-performance engine, the proper flow valve assembly is Part No. 2264344.

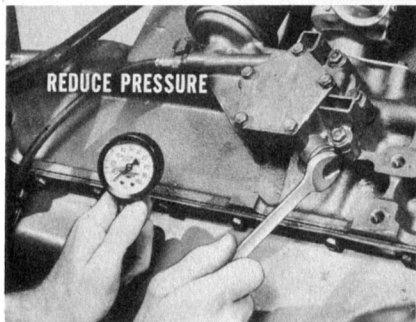
If the camshaft oil relief passage isn't drilled completely through, oil will be trapped behind the camshaft. It can force the camshaft forward and cause a knock. This can also cause leakage at the core plug.

In order to test for this type of hydraulic knock, first attach an oil pressure gauge. Run the engine to bring in the knock. Then, reduce oil pressure a noticeable amount by backing off on the oil pump relief valve nut—or temporarily remove the relief valve spring.

If this pressure reduction affects the knock, pull the camshaft for inspection. If it is necessary to install a new camshaft, be sure to examine it for proper drilling before making the installation.

If reducing oil pressure *doesn't* affect the noise, it is probably a mechanical noise which will have to be tracked down and corrected.

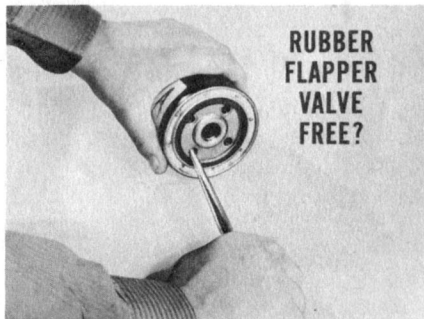
Whenever installing a new oil filter, make this preliminary test. Insert a blunt tool into the holes in the base of the filter and push against the rubber flapper valve to make sure it is free. If the rubber anti-drainback valve is stuck, it will prevent oil flow to the engine bearings. The warning light will go on, or the oil pressure gauge will register no pressure, of course, but sometimes this signal is overlooked by the owner.

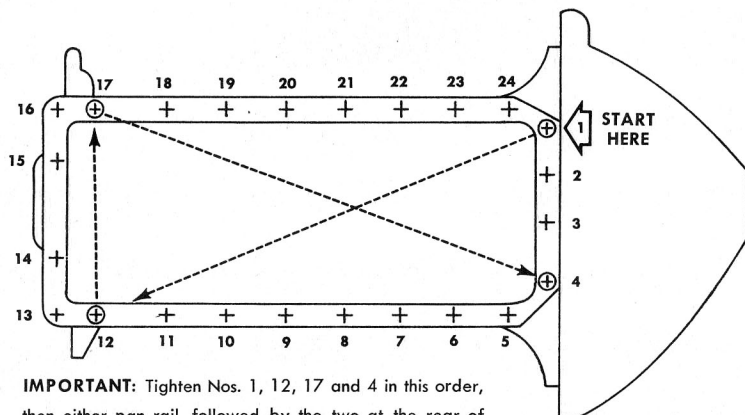
RECOMMENDED TIGHTENING SEQUENCE

The wrong sequence, or overtightening, can compress the gasket too much, or upset transmission - to - crankshaft-centerline alignment.

Oil Pan Tightening. Another thing . . . remember to tighten oil pan retaining cap screws to 17 foot-pounds. And, tighten them in their proper sequence.

IMPORTANT: Tighten Nos. 1, 12, 17 and 4 in this order, then either pan rail, followed by the two at the rear of the pan, then the four at the front.

The recommended tightening sequence for oil pan retaining cap screws is shown in the accompanying illustration.
