SERVICE REFERENCE BOOK

of the MASTER TECHNICIANS SERVICE CONFERENCE

159

Steering and Suspension Service Tips

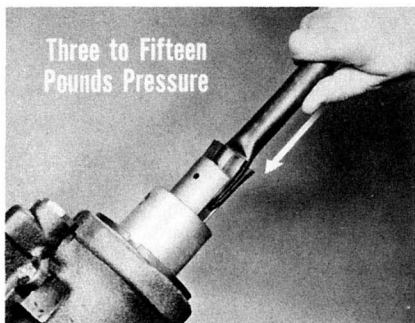
Looseness at this point can be determined by rocking the steering wheel and shaft in the housing. If there appears to be excessive movement, it is possible the rubber insulator and the plastic inserts in the insulator are damaged, or the insulator is undersize.

To correct this condition, remove the steering gear shaft and coupling from the gear. When installing new parts, be sure one insert is assembled on each side of the rubber insulator, and that the nipples on the insulator pass through the holes in the inserts to hold them in position in the insulator.

When these parts are assembled on the blade end of the steering tube, about three-to-fifteen pounds pressure should be required to push the parts into the coupling.

If less than the specified pressure is required to assemble the shaft in the coupling, the insulator might be slightly undersize. In that case, add another insert to one side. This will usually provide the proper thickness of the assembly to prevent looseness at this point.

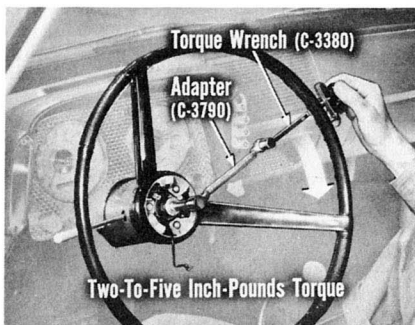
Place Torque Wrench C-3380 with Adapter C-3790 on the steering shaft nut. Rotate the steering wheel at least one complete turn toward the straight-ahead position. The torque required to keep the shaft moving should be between two and five inch-pounds. If the reading is not within these specifications, the worm bearing pre-load should be re-adjusted.

To adjust the pre-load, first loosen the adjuster locknut. Then, turn the adjuster counterclockwise to decrease the pre-load, or clockwise to increase the pre-load. When the desired torque is obtained, tighten the locknut securely.

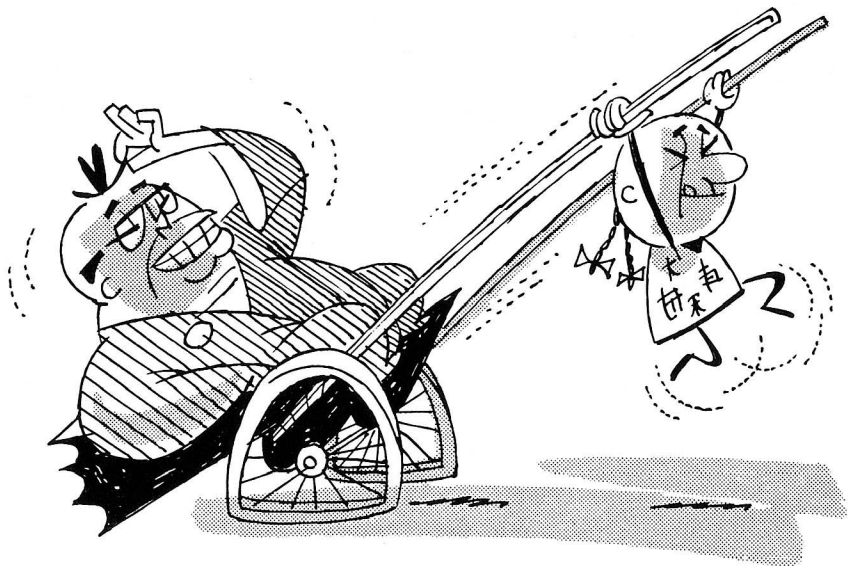
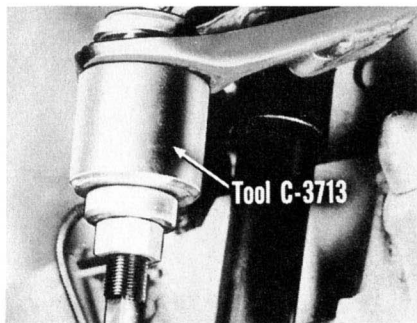
Road dirt thrown up on the ball joints from wet road surfaces or from dusty gravel roads can shorten the life of the joints if they are not properly protected. When work is being done on front suspension parts, careful attention should be given to the condition of the ball joint rubber seals. If they show signs of deterioration, are torn or otherwise are not in satisfactory condition, the installation of new seals will help save the customer the expense of costly repairs later.

When installing new seals, be careful to avoid tearing the seal and damaging the metal retainer. Always use the Seal Installer C-3713 to assure doing a good job.

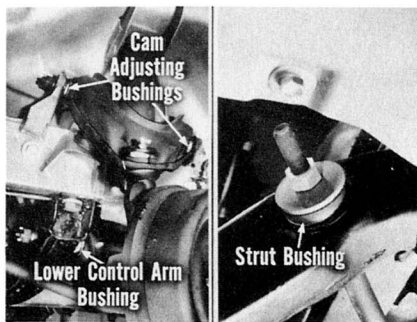
Rubber bushings are used in numerous locations in the front suspension system to absorb road shock. Deterioration or damage to these bushings due to the application of oil or other fluids, and loose connections due to improperly tightened nuts can result in difficulty in maintaining proper front-end alignment. In addition, looseness of the nut on the front end of the strut can also cause brakes to pull the car to one side on brake application.

When preparing to align the front end, it is advisable to first examine the cam adjusting rubber bushings, the lower control arm shaft bushings and, in particular, the lower control arm strut bushings. Any bushing found to be in unsatisfactory condition should be replaced before proceeding with the alignment procedure.
