SERVICE REFERENCE BOOK

of the MASTER TECHNICIANS SERVICE CONFERENCE

**TRANSMISSION
MAINTENANCE**

PREPARED BY CHRYSLER CORPORATION
Plymouth • Dodge • De Soto • Chrysler • Imperial

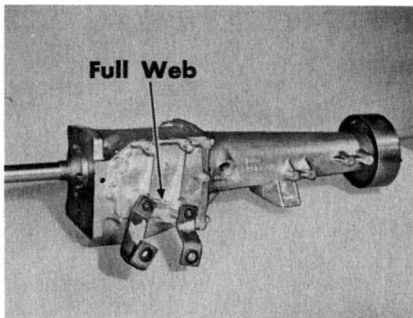
The transmission case is different from the former manually operated transmission, too. The later “L” Series transmission can be identified by the new gearshift housing which has a full web between the two gearshift shaft bosses.

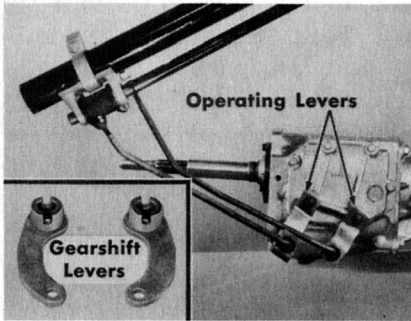
The gearshift linkage used with the new "L" Series transmission is different from the linkage formerly used. The gearshift operating

levers are the same length as the earlier series, but are of different shape. Gearshift rod levers at the lower end of the steering column are of equal length, but also of different shape than formerly. However, the adjusting procedure is the same for both linkage mechanisms.

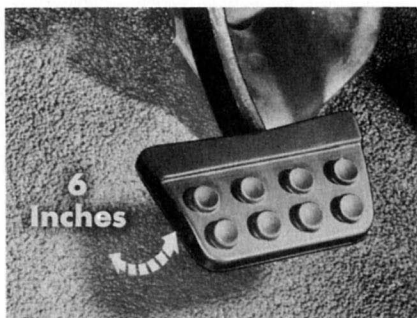
If the pedal doesn't have proper travel, check for interference between the clutch pedal and the clutch pedal rod—the perpendicular

rod between the pedal and the torque shaft. Sometimes, springing the clutch pedal bracket slightly will provide the necessary clearance. If, however, you have difficulty in getting the six inches total travel you may have to install the new, shorter clutch pedal rod, part number

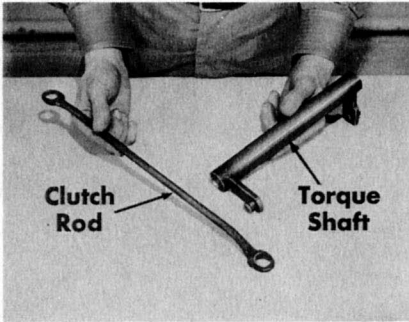
1829406, and the new clutch torque shaft with the longer lever on the tube at the clutch end. Two shafts are available, one (part number 1829402) for all standard models, and the other (part number 1829407) for the high-performance models. In each case, the new rod and shaft must be used as a set.

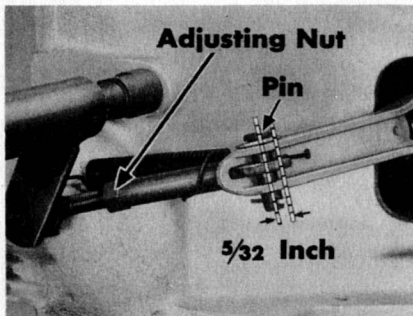
Clutch Pedal Free-Play Adjustment. Clutch pedal free-play is important, to insure that the clutch is completely engaged when the pedal is at the at-rest or clutch-engaged position. So, check the free-play by measuring the free travel at the clutch release fork pin—the distance from the at-rest position to the point at which the clutch starts to release. This distance should be $5/32$ -inch. You can also

take this measurement on the release fork rod, between the adjusting nut and the tubular portion of the rod. Adjust the fork rod “in” or “out” as required, to obtain the exact dimension. That distance— $5/32$ -inch—will give one inch of free pedal movement, measured at the pedal pad.

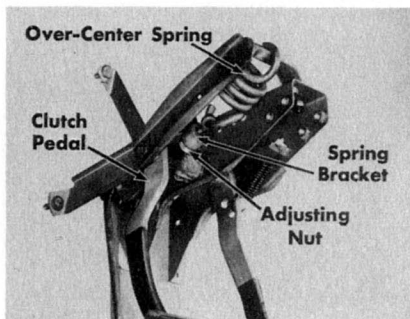
Clutch Pedal Over-Center Spring Adjustment. The over-center spring is used to reduce the amount of foot pressure needed to release the clutch. If the clutch operation needs adjusting, loosen the adjusting nut until the pedal drops to the floor. Then tighten the adjusting nut

against the spring bracket five full turns for six-cylinder cars, and seven full turns for eight-cylinder cars. Check the pedal action. If heavier pressure is desired, loosen the nut one turn; if lighter action is desired, tighten the nut one turn. Specifications call for 30 to 32 pounds pressure at the pedal pad. If the nut is too tight it will cause a lazy pedal return—may even stick the pedal at the floor. Too little spring tension will cause a hard pedal.

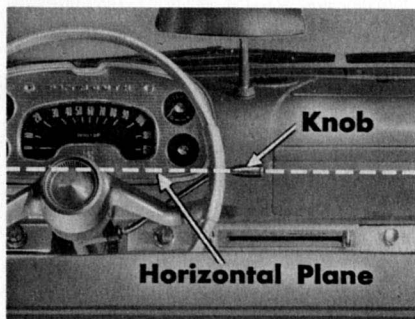
The first point to check is the position of the gearshift lever *knob*. Sight through the rear window, or sight over the end of the lever and knob to a horizontal section of the instrument panel. See if the centerline of the gearshift lever *knob* is in a horizontal plane. Move the lever through the neutral position crossover several times, and release it. The lever should drop down, and the knob should be in a horizontal plane.

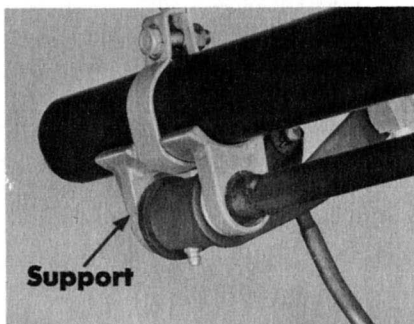
To bring the slots into line, adjust the low-reverse rod—the upper one—by adjusting the two nuts at the swivel, so the gearshift tube pin can be moved up or down through crossover, without interference.

The next point is to check the operation of the shift lever to be sure it has equal crossover-direction free-play in the high-second and low-reverse positions. Also check to see that there is sufficient clearance between the rim of the steering wheel and the knob on the shift lever.

If you have to make an adjustment to provide this clearance, move the lower support up or down on the steering column to properly position the pin and obtain the correct free-play.

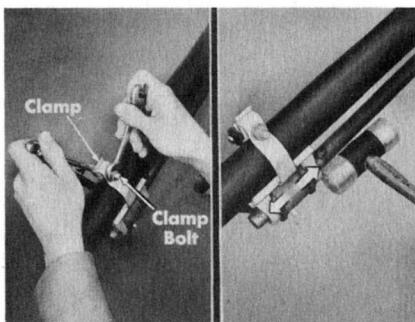
Just loosen the lower support (two clamp bolts on early models, a single clamp bolt on later models) and tap the support up or down. When the proper clearance has been obtained, tighten the clamp bolts. If you are working on a "K" Series manual steering job, tighten the clamp bolt 120 inch-pounds. Tighten it to 90 inch-pounds on "K" Series power steering models. The single clamp bolt on "L" Series manual steering jobs is tightened to 40 inch-pounds; on "L" Series power steering jobs, tighten to 205 inch-pounds.

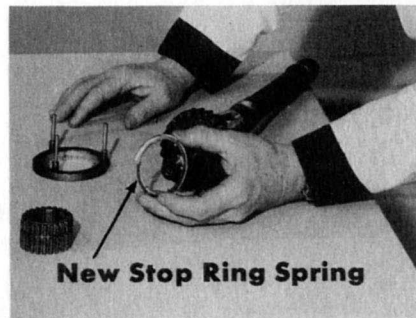
When inspecting the synchronizer, make sure the stop ring pins are straight, and are tight in the ring. If they are not straight, or if they are loose in the ring, replace the ring.

Loose pins in the pin-type synchronizer do not interfere with its operation.

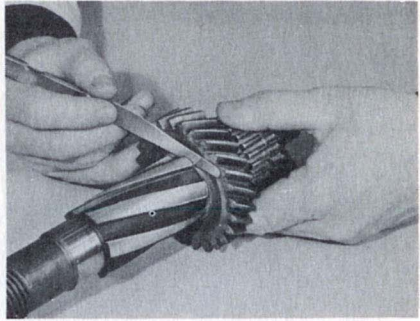
When assembling the synchronizer, use the new thinner, lighter load stop ring spring, part number 1823916. This new spring improves shifting into second, and will prolong the life of the synchronizer.

Also, when assembling the transmission, check the second gear end play. It must be between .003 inch and .008 inch. End play in excess of .008 inch might let the gear work out of mesh, or might result in noise.

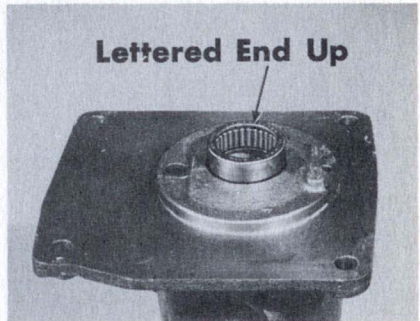
Another point that deserves careful attention is the mainshaft roller bearing which is pressed into the bore at the front end of the extension housing. If this bearing is worn or damaged it will cause a noise that will be heard in all gears and at all speeds.

If this bearing needs to be replaced, set it in the bore with the lettered end up, and press it in until it is flush and square with the end of the housing.

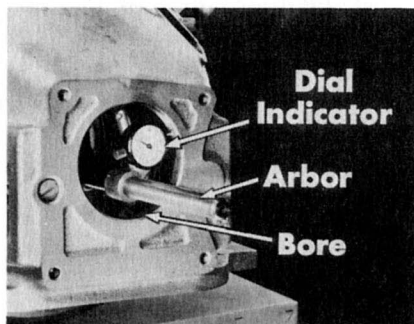
Clutch Housing Bore and Face Runout. With the transmission and clutch removed, mount the arbor (C-870) on the flywheel, and then mount the dial indicator (C-435) on the arbor, with the indicator arm contacting the housing bore. Rotate the flywheel and read the amount of runout on the dial. A runout of over .004 inch should be corrected.

With the transmission and clutch removed, mount the arbor (C-870) on the flywheel, and then mount the dial indicator (C-435) on the arbor, with the indicator arm contacting the housing bore. Rotate the flywheel and read the amount of runout on the dial. A runout of over .004 inch should be corrected.

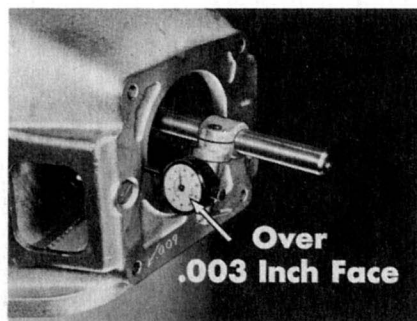
Mark the amount and the direction of greatest runout, and then shift the dial indicator farther out on the arbor so the dial contact arm rests on the face of the housing. Again, rotate the flywheel and read the total runout of the face of the housing. A total runout of .003 inch is the limit—more than that calls for a correction.

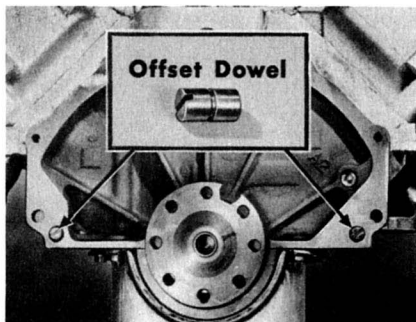
If excessive runout is found during both inspections, the corrections can be made during the same operation, or each correction can

be made individually. For example, the correction for housing bore runout involves removing the housing and removing the dowels. Install offset dowels (available in .007", .014" and .021" offset) of the proper offset to permit shifting the housing one-half the total amount of the runout measured.

To determine the size dowel to use, let's assume that the indicator reading is .016" in a direction approximating 2 o'clock on the rear face of the engine. This means the housing is off .008"—one-half the total reading. So, you would select the .007" offset dowel, and install two of them. This will permit a correction of .007", leaving the runout still .001". Since the allowable runout is .004", this job will then be well within the allowable limit. Slots in the ends of the dowels must be kept parallel, because they indicate the direction of greatest offset.

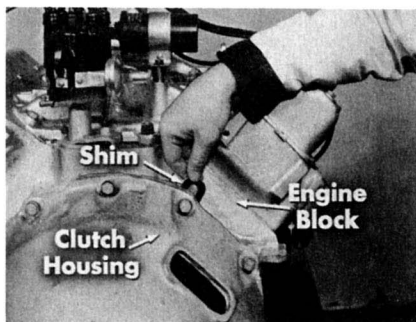
At the same time, correcting face runout involves installing shims of the proper thickness between the clutch housing and the engine block. So, while the mounting bolts are loose, install shims as needed to bring the housing face into alignment. When the housing is properly aligned, tighten the mounting bolts to 50 foot-pounds torque.

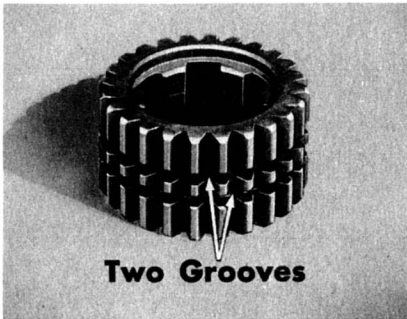
New Synchronizer Unit. When a transmission is disassembled, inspect the teeth of the synchronizer clutch gear, main drive pinion and second speed gear. If they are damaged, use the new clutch gear, part number 1853672 as a replacement. This gear can be identified by the

two grooves instead of the single groove of the former gear. This new gear can be used for replacement in any transmission using the pin-type synchronizer. If you install the gear only, be sure to use the new, lighter-load synchronizer stop ring spring, part number 1823916.

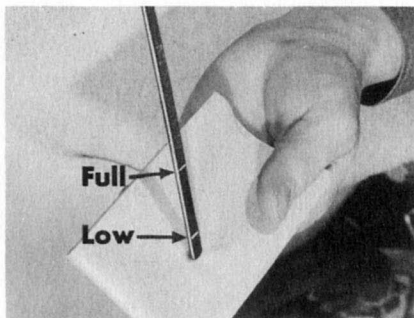
Fluid Level. Erratic performance of the transmission, particularly its shifting performance when hot, can often be traced to incorrect fluid level. Fluid level should be checked with the engine running at normal idle speed, the transmission in neutral, and the hand brake applied. All five push buttons should be operated slowly, returning to the neutral button each time. The fluid level on the indicator should be between the low mark to one-half inch *below* the low mark if the fluid is cold. After the car has been driven approximately ten miles and the fluid level is checked, the level will have risen to between the low mark and the full mark. Only Automatic Transmission Fluid – type “A” should be used. Overfilling leads to foaming, and loss of pressure, resulting in erratic shift performance.

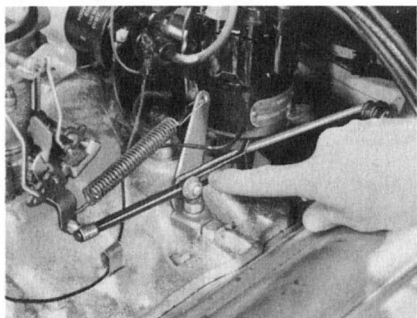
Throttle Linkage Adjustment.

The procedure for adjusting throttle linkage has been given in previous publications, and will not be repeated here. However, it might be well to review the importance of making this adjustment so everyone will understand why it is a major part of proper diagnosis. Many reports of harsh shifting, and clutch slippage during acceleration can be traced directly to inaccurate throttle linkage adjustment—when those adjustments were made the conditions disappeared.

The throttle linkage acts directly on the throttle pressure valve in the transmission. Throttle pressure ranges from Zero at closed throttle to 90 psi at wide-open throttle. Since the amount of throttle opening and resultant throttle pressure determines the road speed at which the transmission shifts to the various speed ranges, it is easy to understand why incorrect throttle linkage adjustment can result in the wrong throttle pressure being present at a given throttle opening. If the pressure is too high, the shift is harsh; if the pressure is too low, the clutch or band will slip and the engine will race.

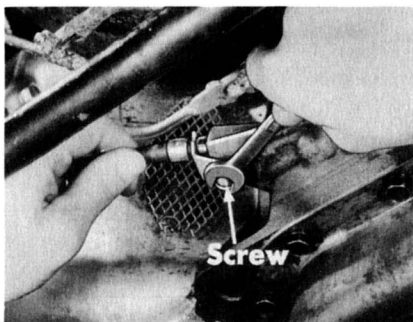
Push-Button Cable Adjustment. Many a case of poor shift performance, engine runaway and clutch slippage has been blamed on the transmission when the actual cause was incorrect push-button cable adjustment. Let's see how this cable adjustment can affect the operation of the transmission.

It is important, as you can see, that the push-button cable adjustment be checked before any disassembly of transmission components is attempted. And, when you adjust the cable, have someone hold the "R" button all the way IN. This removes all the free-play at the push-button box. Then loosen the screw which holds the control cable adjustable bracket to the adapter housing. Remove the neutral starter switch and hold the manual valve lever in the Reverse detent position. Push the cable into the housing, and mark it. Then, gently, pull it out, and mark it again.

Now, slowly push the cable into the housing *one-half* of the total travel. Tighten the bracket screw to secure the adjustment, making sure the cable ferrule doesn't move.

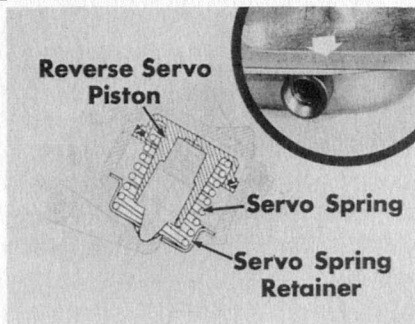
Reverse Servo Spring and Retainer. Transmissions having the letter “J” (or letters following alphabetically) stamped on the right-side pan rail of the case use a new reverse servo spring, part number

1824316, and a new spring retainer, part number 1824317. These parts are designed to prevent the “no reverse” condition some owners have reported. The parts prevent the servo piston from cocking over and missing the pilot hole in the reverse band lever.

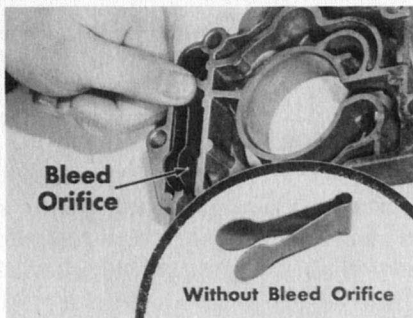
Front and Rear Pump Check Valve. In order to improve line pressure at idle and low speeds, the installed position of the front and rear pump check valve in the regulator valve body was changed. This

placed the small bleed orifice inward, against the front pump pressure port. This change became effective with transmission serial number 547,000. If you have occasion to service a transmission prior to the above serial number, install the valve with the orifice facing the front pump pressure port.

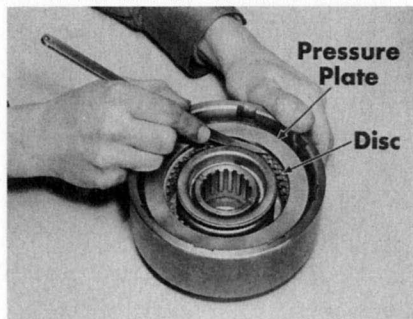
Rear Clutch Clearance. While emphasis has been placed on checking the clearance in the front clutch, occasionally it is necessary to check the rear clutch clearance. Usually the clearance is right if the correct number of plates and discs have been installed. Since there are two sizes of rear clutches, it is well to remember the clearance for each. The clutch using 4 plates and 4 discs should have a clearance of from

.056" to .128". The clutch with 5 plates and 5 discs should have a clearance of from .070" to .160". The clearance can be checked with a feeler gauge between the pressure plate and the first driving disc, similar to the manner of checking the front clutch clearance.

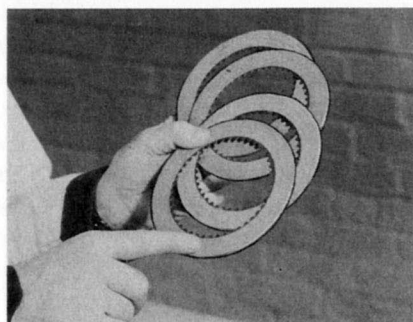
Front Clutch Friction Material.

To improve the performance of the front clutch, a new friction material is being used on the driving discs. This material is capable of withstanding higher unit loads, and will tend to prevent slippage while increasing the life of the clutch.
