SERVICE REFERENCE BOOK

STEERING SERVICE TIPS FOR 1960

PREPARED BY CHRYSLER CORPORATION

NEW MANUAL STEERING GEAR

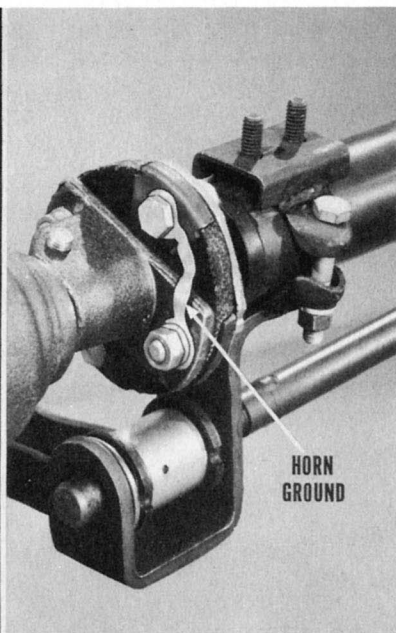
Horn Wire Routing. The horn wire formerly extended down through the steering tube and out the lower end of the gear housing. Because of the new flexible coupling construction, the horn wire now leaves the column jacket with the directional indicator wires, above the coupling. In addition, a copper ground strap is attached to the underside of the coupling to complete the horn ground circuit.

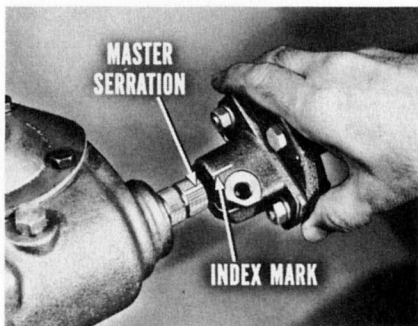
Align the index mark on the outside of the lower hub with the marked master serration on the worm shaft. Then, slide the coupling on the worm shaft. Next, mount the gear housing to the frame side rail and tighten the attaching bolt nuts to 50 foot-pounds torque.

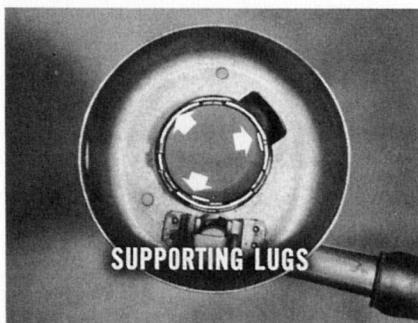
To inspect the bearing, it is necessary to remove the steering wheel and column jacket. Before removing the jacket, remove the upper snap ring from the upper end of the tube, using Pliers C-3229.
