SUBURBAN and CONVERTIBLE BODY SERVICE

PREPARED BY CHRYSLER CORPORATION

Dodge • Plymouth-De Soto-Valiant • Chrysler and Imperial Divisions

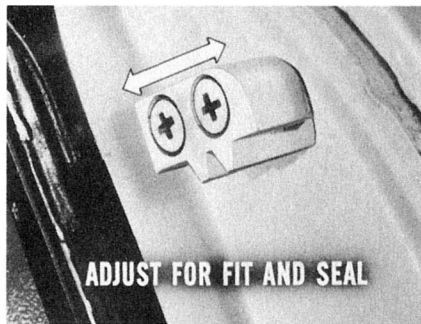
Striker Plate Adjustment. Adjust the strikers for flush fit of the upper part of the tailgate panel with the quarter panels, and for a tight seal against the weatherstrip. Avoid moving the strikers in too far because the gate will bounce back without latching. Said another way, move the strikers in far enough to get the required fit and still get consistent latch engagement. After making the adjustment, check it by closing and opening the gate several times. Note whether the tailgate latches

each time it is closed, and releases easily when operating the latch handle. You may need to move the strikers more than once. If necessary, you can add or remove shims behind the strikers to improve rotor engagement.

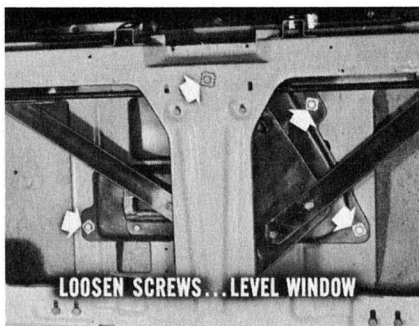
If it is necessary to adjust the position of the glass, remove the gate cover panel, the garnish molding and the paper watershield. Loosen the four regulator plate mounting screws and shift the regulator as required to equalize the spacing between the top of the glass and the roof rail. Then tighten the mounting screws.

To level the tailgate window, close the gate and run the window up to within an inch of the roof rail, then loosen the four regulator plate screws and shift the regulator plate. RIGHT **2** WRONG

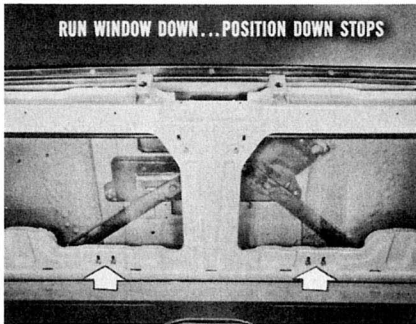
Loosen the lower stop screws near the bottom of the gate. Lower the glass until the top of the frame is even with, or slightly lower than the top of the tailgate outer panel. Hold the stops against the glass frame, and tighten the screws to limit the downward travel of the glass.

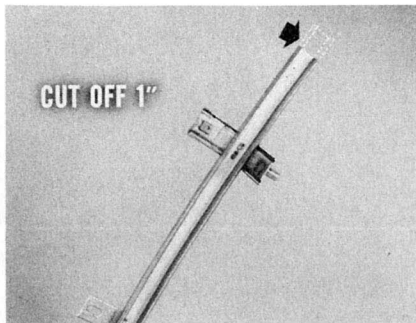
Run Channel Modification. On some early production models the upper ends of the glass run metal channels may not allow enough forward movement to align with the body channels. In a case like this, remove the glass assembly and both glass run channels.

Cut or grind off the staple that holds the glass run rubber channel and remove the rubber. Rework both metal channels by cutting about 1" off the top. This will eliminate interference and provide extra fore-or-aft adjustment.

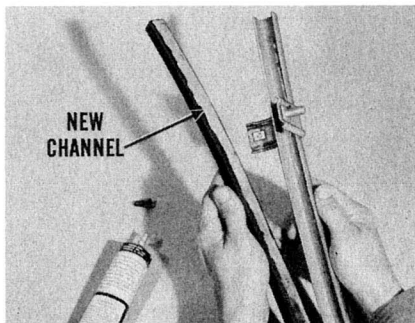
Install new glass run rubber channels (Part No. 1961556) into the metal channels. Let the upper end of the rubber channel extend above the end of the metal channel a distance equal to the amount cut off the metal channel. Use a two-coat cement application to secure the new rubber glass runs. Re-install the reworked channel assemblies in the tailgate.

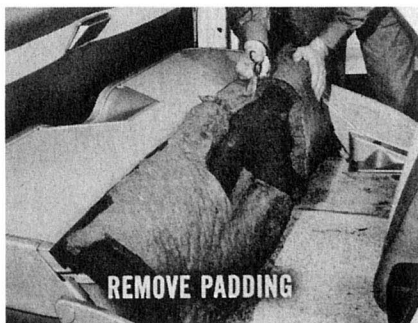
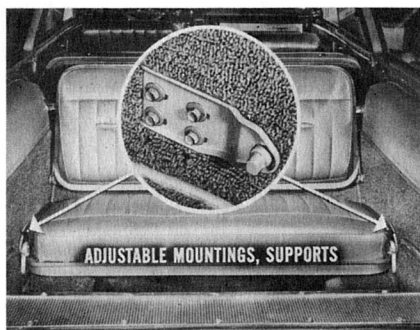
Third Seat Adjustment. On three-seat suburbans, the third seat back and cushion also have adjustable mountings and supports. By loosening the bolts, you can move the mountings to get a more level cargo-carrying surface whenever required.

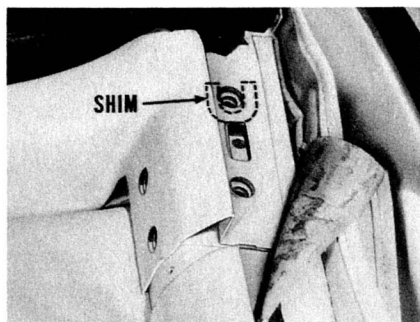
NOTE: In some cases it may be necessary to rotate the leading edge of the top header downward to improve sealing . . . particularly at the outer ends of the header. The top header can be rotated by inserting a spacer approximately $\frac{1}{8}$ " thick between the side rail and the windshield

header at the forward screw. To install this spacer, remove the two screws from the underside of the roof rail, and loosen the two side screws.

Insert the spacer between the header and the roof rail, and slide it all the way forward until it lines up with the *forward screw hole*. Align the top header and tighten all four screws. Tighten the two screws under the roof rail first, then the two side screws.

Lay a bead of sealer along the entire length of the roof rail weatherstrip retainer before you install it. This is good insurance against water leakage between the weatherstrip retainer and the roof rail. If there is any gap between the forward end of the roof rail weatherstrip retainer and the rubber header weatherstrip, fill it with sealer to prevent leakage above the vent wing.

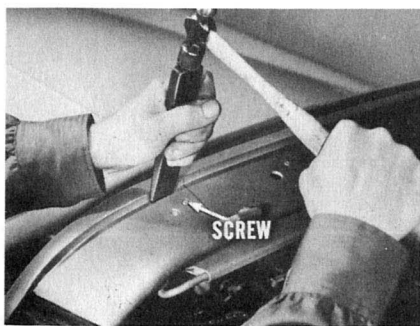
If the inner end of the side molding doesn't fit down tight against the header molding, don't fill the lap joint gap with sealer. A gap between the two moldings at the lap joint results in a step-off that is too great to be sealed effectively by the top header weatherstrip. If the gap at the lap joint has already been filled with sealer, remove the side moldings and clean off all the old sealer. To insure a good fit at the lap joint, drill a hole about $\frac{1}{2}$ " from the inner end of the side molding, and in line with the other screws. Install a sheet metal screw. The additional screw will reduce the step-off condition between

the outside side molding and upper windshield header molding. If necessary, rework the end of the side molding to reduce the step-off by reforming the fillet after installing the additional metal screw. After the lap joint gap is eliminated, wipe sealer into the joint.

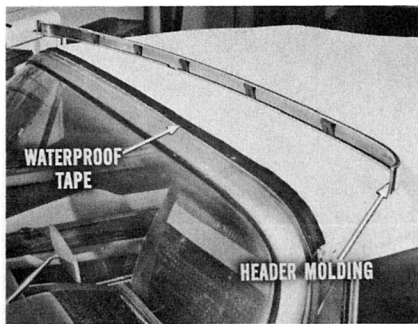
slot in the weatherstrip fits over the flange at the forward edge of the top header.

Apply cement to the top fabric and to the top surface of the weatherstrip. Then install the 1¼" x 62" strip of waterproof tape. Be sure to cover all the staples and tabs so there is a waterproof bridge from top material to header weatherstrip, to provide a good seal.

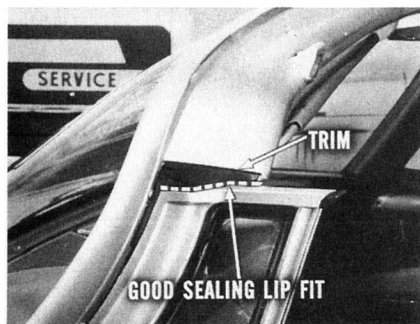
You may have to either shim or trim off the top of the seal to get a good sealing lip fit along the top edge of the vent frame. Incidentally, be sure to clean the area thoroughly with cement solvent to

remove all the old sealer. Also, clean the seal to remove any powder on the exterior. Apply cement to the body pillar and the seal. Let it dry until tacky, then press the seal into place. In some cases you may have to install a new seal to stop a leak at the upper edge of the vent wing frame.
