Service Reference Book

MASTER TECHNICIANS SERVICE CONFERENCE

165

MANUAL TRANSMISSION SERVICE

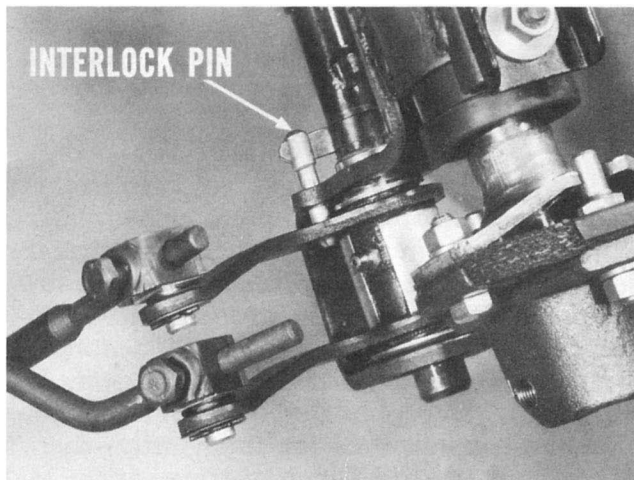
Fig. 1—Heavy-duty linkage

In 1961 Chrysler Corporation cars, two types of column-mounted gearshift linkages are used: a standard linkage and a heavy-duty linkage. The heavy-duty linkage can be identified by an interlock pin attached to the lower end of the shift tube. When a shift is made to second or high, this pin is moved through a hole in the shift lever bracket to engage a matching hole in the low-reverse shift lever. This serves to lock the low-reverse shift lever positively in neutral. The standard linkage doesn't have this interlock pin.

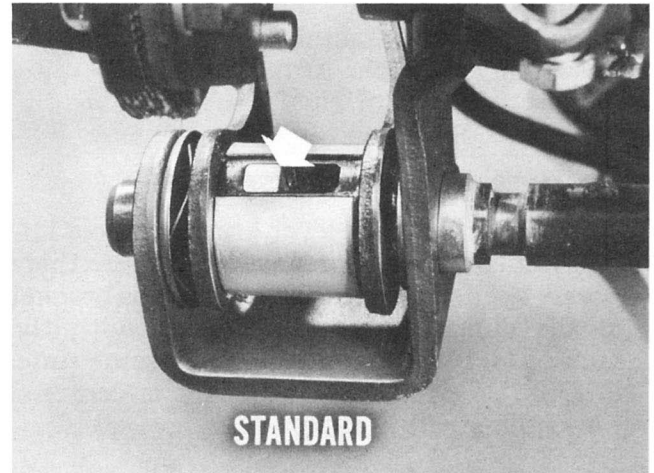
Fig. 2—Crossover pin, standard linkage

The standard linkage has a crossover pin with a square head. The flat sides of this pin insure that the shift lever hubs will not move while the pin is passing through the slots from one hub to the other during crossover from low or reverse to second or high.

Never install the wrong crossover pin with either linkage. A round-headed pin could cause the standard linkage to jam up during quick gearshifting, while a square-headed pin would make it difficult to obtain a smooth crossover in the heavy-duty linkage.

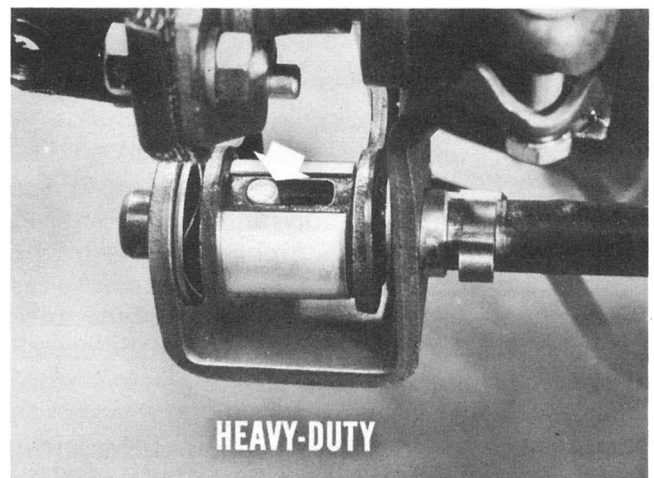
Fig. 3—Crossover pin—heavy-duty linkage

The heavy-duty linkage has a crossover pin with a round head. In this linkage, the inter-

lock provides protection against movement of the hubs during crossover, so the square-headed pin is not required.

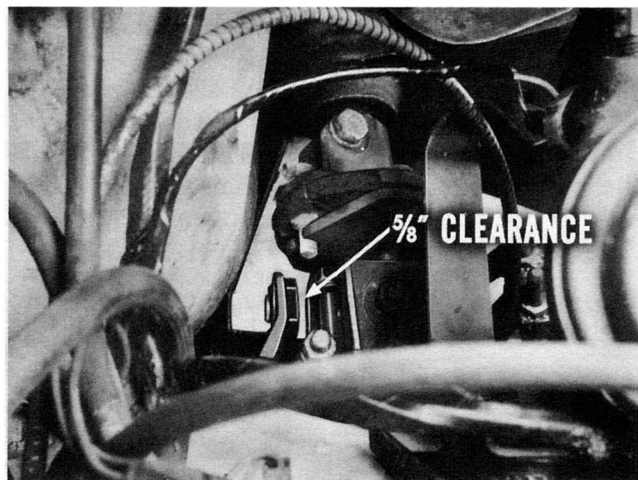
Fig. 4—Shift lever bracket clearance

In the area of the shift lever bracket, two additional items should be inspected. Be sure there is about $\frac{5}{8}$ -inch clearance between this bracket and the clutch torque shaft arm, with the clutch pedal fully depressed. At the same time, see if the steering column jacket is centered around the steering tube.

If either condition is not correct, loosen the lower column clamp bolt and the four stud nuts which attach the support bracket to the clamp and the firewall. Turn the clamp as necessary to establish the $\frac{5}{8}$ -inch clearance between the shift lever bracket and the clutch torque shaft arm.

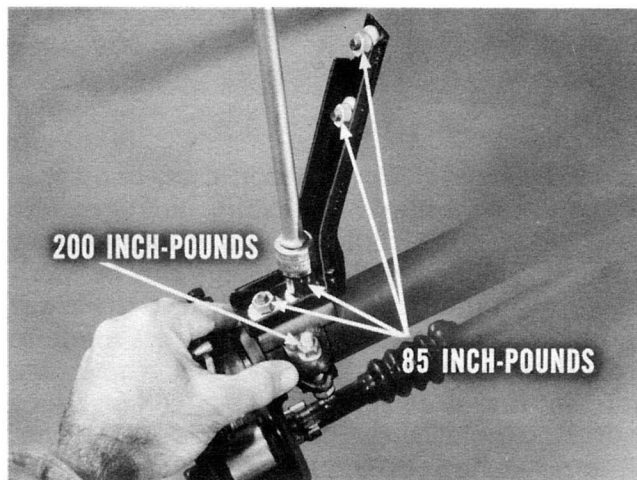
Fig. 5—Steering column jacket centered

Hold the jacket centered around the steering tube while tightening the clamp bolt and the four stud nuts. Tighten the clamp bolt to 200

inch-pounds and no more, or the clamp might take a "set" and make future adjustment difficult. Tighten the four stud nuts to 85 inch-pounds.

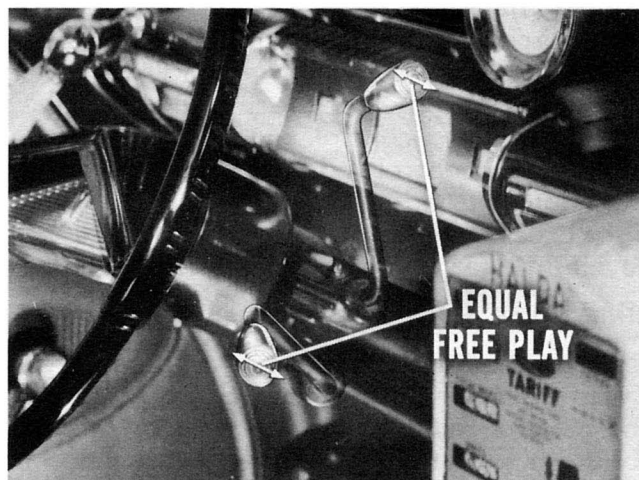
Fig. 6—Test crossover pin travel

Crossover pin travel must be adjusted so there is no possibility of incomplete crossover. To test crossover pin travel, slide into the driver's seat and pull the gearshift lever into the low-gear position. Wiggle the lever up and down—parallel to the steering column—and note the free play. Repeat this test in second gear. The amount of free play in both lever positions should be equal. Feel for this gently—there's only about $\frac{1}{8}$ - to $\frac{1}{4}$ -inch of travel at the end of the gearshift lever, normally.

Hard shifting may result if the free play in both positions isn't equal. To correct this con-

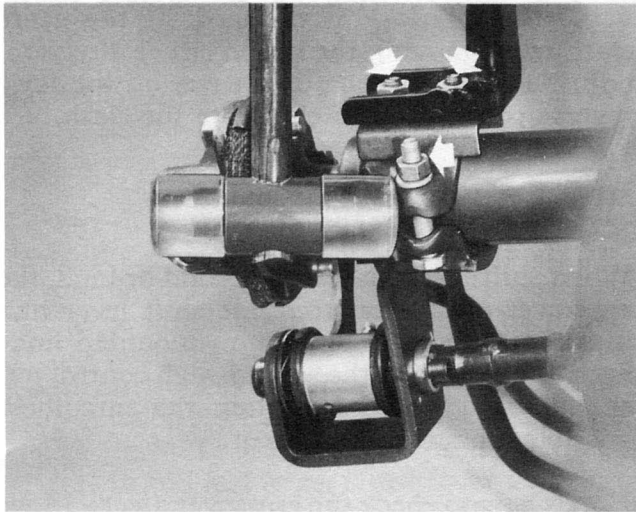
Fig. 7—Adjust crossover pin travel

dition, slightly loosen the lower column clamp bolt and the two stud nuts which hold the column clamp to the support bracket. Then, using a soft plastic-faced hammer, tap the clamp up or down the column. *Up*, if there is inadequate free play in second gear; *down*, if there is too little free play in low. And take it easy with the hammer.

Remember, you probably won't need to move the clamp more than a few thousandths of an inch to equalize the free play. When it's set, tighten the clamp bolt and stud nuts to the torque values specified earlier.

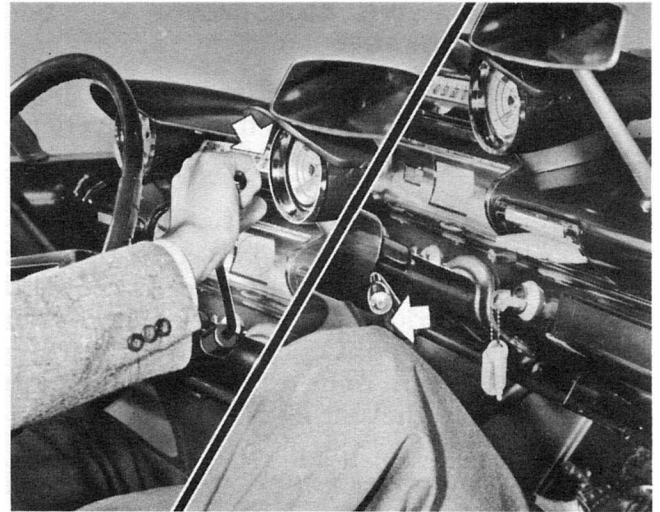
Fig. 8—Adjust gearshift lever position

If adjustment is required, decide how much the gearshift lever should be moved, and in which direction. Then, with the transmission in neutral, loosen the swivel on the low-reverse control rod. Have someone pull the gearshift

lever up into the low and reverse side and hold it steady in the desired neutral position. Gently move the low-reverse control rod back and forth just enough to be sure the neutral detent in the transmission is fully engaged, then tighten the swivel adjusting locknuts or clamp screw. Changing this adjustment will affect the "feel" of the crossover, so be sure to make the adjustment described under the heading "SECOND-HIGH SWIVEL ADJUSTMENT" after readjusting the low-reverse control rod swivel.

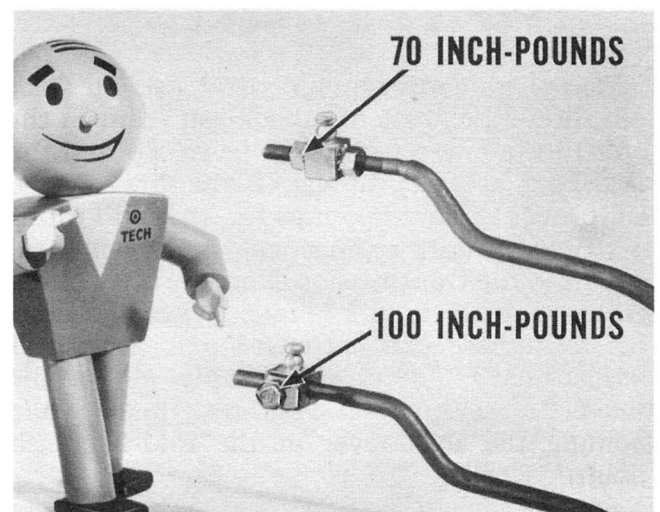
Fig. 9—Swivel types and torques

Some swivels are held to the control rods by a clamp and clamp screw. Others use two swivel adjusting locknuts. Tighten the clamp screws to 100 inch-pounds of torque; tighten the adjusting locknuts to 70 inch-pounds.

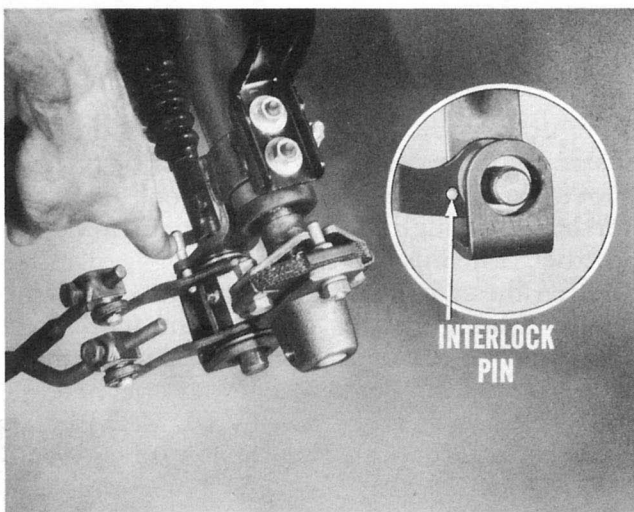
Fig. 10—Center the interlock pin

However, it's absolutely essential that the low-reverse control rod swivel be set so that the hole in the low-reverse shift lever is centered around the interlock pin when this lever is in the neutral position. Otherwise, hard shifting and clashing gears may result. Here's how to test and adjust the setting of this swivel.

With the transmission in neutral, the interlock pin should be at its mid-backlash point in the hole in the low-reverse shift lever. To find the mid-backlash point, wiggle the low-reverse shift lever up and down as far as it will move with the interlock pin engaged. The neutral detent in the transmission should hold the low-reverse shift lever at a point precisely halfway between these two extremes of its travel. If adjustment is necessary, simply loosen the swivel on the control rod and retighten it while holding the shift lever at the mid-backlash point.

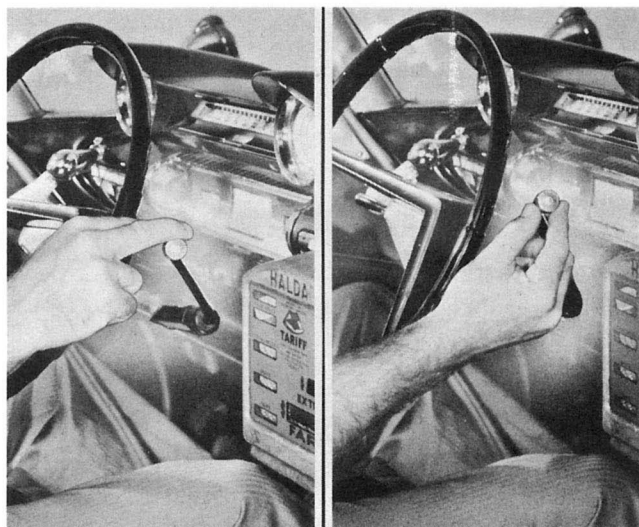
Fig. 11—Test crossover "feel"

Here's how to check the crossover "feel". Move the gearshift lever up and down through the crossover several times while holding a slight downward pressure on the gearshift lever. This will hold the crossover pin against the right-hand edge of the slots in the two shift lever hubs. In this way, you'll be more able to feel any misalignment of this edge of the two slots. Repeat this with slight upward pressure on the lever, to press the pin against the left-hand edge of the slots in the hubs.

The crossover action should be smooth. Eliminate any “lumpy” feeling caused by misalignment of the slots by adjusting the position of the swivel on the second-high control rod—never by changing the setting of the low-reverse control rod swivel.

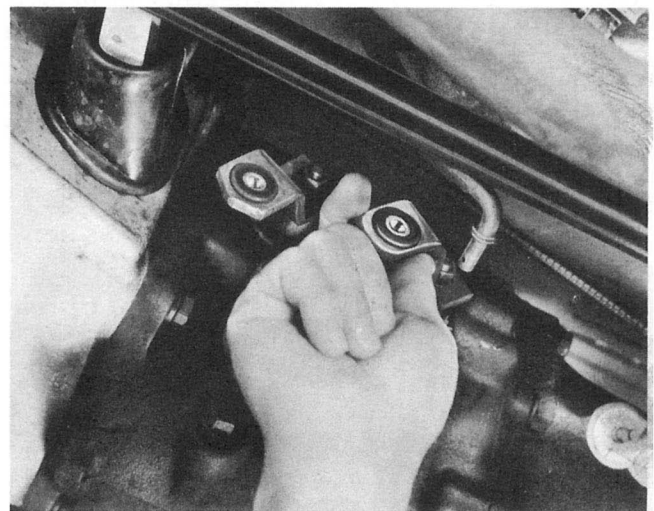
Fig. 12—Test for binding inside transmission

If it’s questionable whether the binding is in the linkage or in the transmission, disconnect both control rods from the shift levers at the transmission. Then operate the transmission shift levers, one at a time, by hand. Don’t forget to return them both to neutral when you’re finished, though. Causes of hard shifting originating inside the transmission are covered later in this Reference Book.

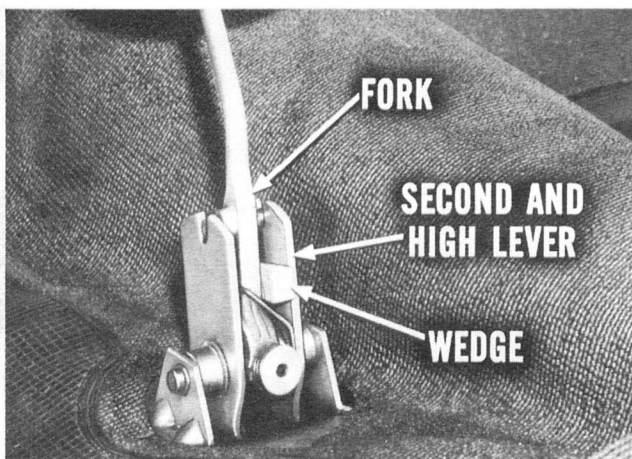
Fig. 13—Wedge keeps crossover pin engaged

If linkage adjustment is needed, raise the boot and slide a wedge between the second-high lever and the gearshift fork to keep the crossover pin engaged in both levers. This effectively locks the two levers together in neutral to maintain the proper crossover alignment while adjustments are being made.

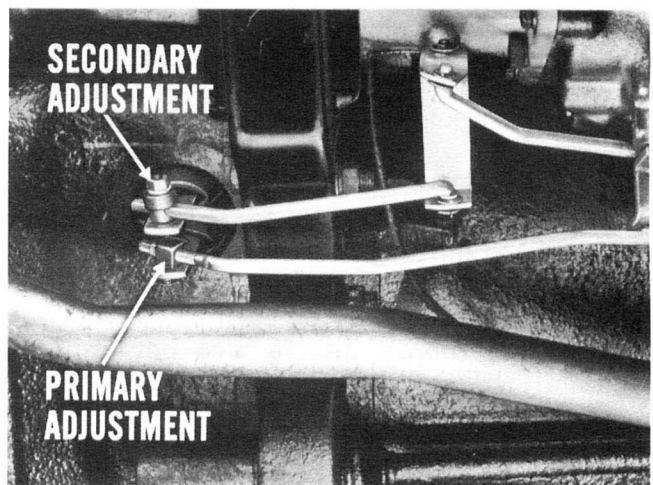
Fig. 14—Control rod adjustment points

From underneath the car, disconnect the control rod swivel from the first-reverse lever. Also loosen the swivel clamp nut on the second-high control rod to allow the two locked levers to move as necessary during adjust-

The primary adjustment is made by loosening the locknut on the end of the first-reverse control rod and moving the swivel block back or forth on the rod to position the gearshift lever. You can change the angle of the gearshift lever to suit the individual owner. Just move it to the position desired and adjust the swivel block to line up with the hole in the first-reverse lever. When it's set, coat the swivel block stud with Lubriplate and connect it to the first-reverse lever. Tighten the locknut.

During the primary adjustment, the second-high control rod was free to slide back and forth in its loosened swivel. The secondary adjustment, which establishes the smoothest possible crossover shift action, is made at this swivel. To make this adjustment, slide the second-high control rod back and forth gently through the loosened swivel clamp to find the mid-backlash position of the linkage. Do this very carefully to keep the shift lever at the transmission from moving out of the neutral position. When you've found the right spot, tighten the clamp nut in the swivel to 100 inch-pounds of torque.

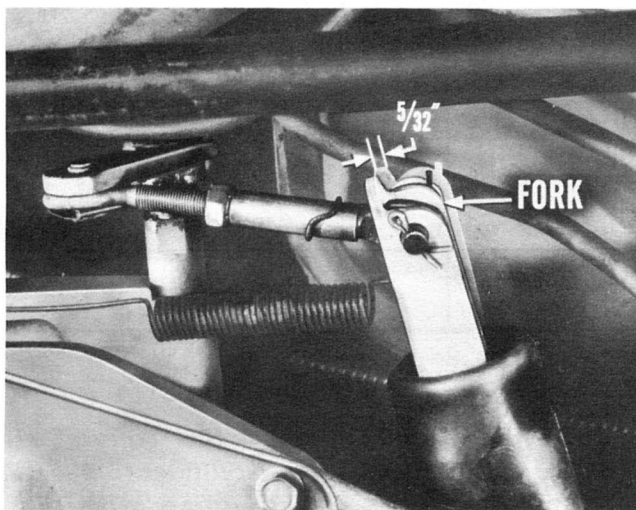
Fig. 15—Clutch free play

Maximum clutch life and good operation depend on the right amount of clutch pedal free play—the amount of pedal movement before the clutch starts to disengage. On all models, there should be $\frac{5}{32}$ -inch free movement of the clutch release fork, measured at its outer end.

This will give you about an inch of free travel of the pedal. However, don't attempt to gauge

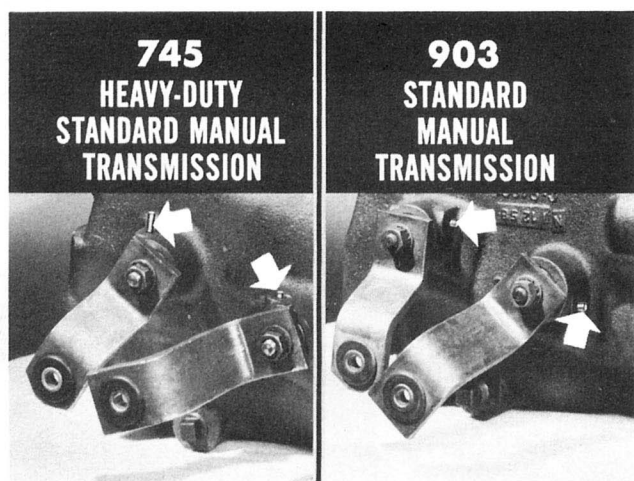
Fig. 16—Retainer pins identify transmission

And, with cars built in the United States, be sure you know which of the two current transmission models you're working on. The two models are very similar in design features and appearance. The 903 standard manual transmission, referred to as the standard 3-speed synchroshift transmission in the Service Manuals, is standard equipment with all six-cylinder engines and the 318-cubic-inch V-8. The 745 heavy-duty standard manual transmission, referred to as the standard 3-speed heavy-duty transmission in Service Manuals, is standard on the larger V-8's. It's also optional for the smaller V-8 engine as well as Plymouth and Dart six-cylinder engines.

Here's a sure way to tell these two models apart, even when they're installed in a car. Examine the retainer pins in the two gearshift lever shaft bosses on the left side of the transmission case. These two pins are *horizontal* on the 903 standard manual transmission; they are *vertical* on the 745 heavy-duty standard manual transmission.

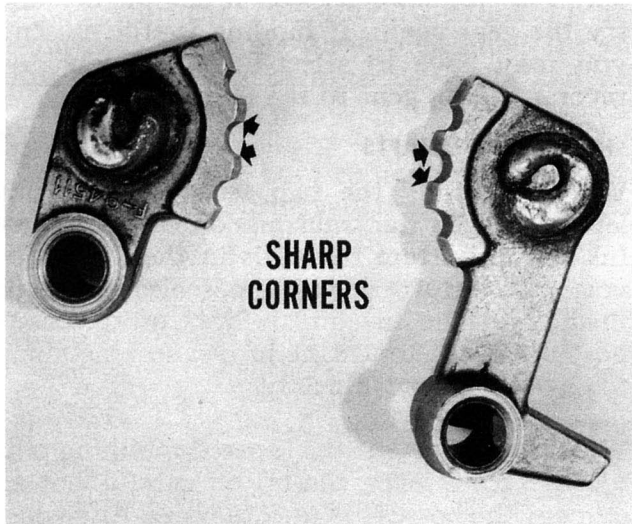
Fig. 17—Stone-off neutral detent notch

If the trouble was a sticking feeling coming *out* of neutral when shifting to another gear, it may have been caused by sharp corners at the neutral detent notches of the transmission shift lever cams. It's a good idea to inspect for this condition whenever the transmission is disassembled.

Use a fine stone to round off the corners of the neutral detent notch. Be very careful not to round off the corners too much or the shift levers may develop a tendency to slip out of neutral.

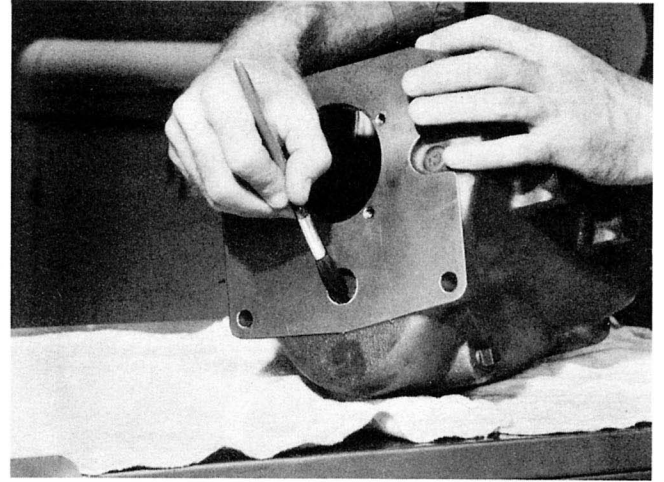
Fig. 18—Seal countershaft bore

Look for signs of a lubricant leak past the countershaft at the front of the transmission case. To prevent leakage, apply a thin even coat of MoPar or Chryco gasket sealer to the inside of the bore for the countershaft in the transmission case during reassembly. Do this just before you drive the countershaft all the way into place. Apply the sealer from the front of the case, not from the inside. And don't let it overflow onto the machined front surface of the case or into the case.

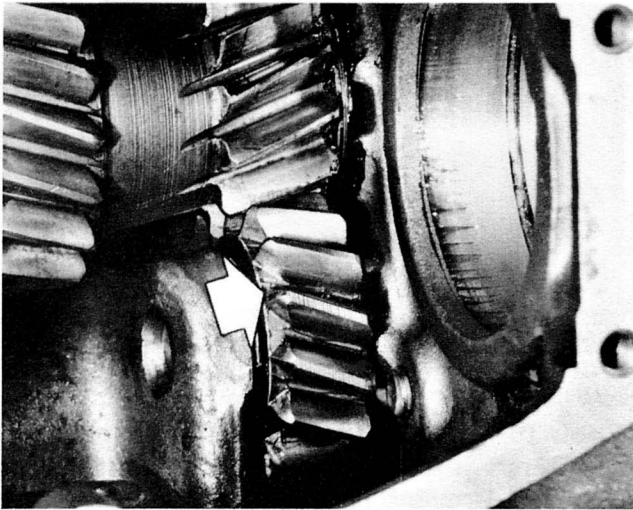
Fig. 19—Reverse idler properly installed

Be sure to get the reverse idler gear installed properly—it's easy to put this in backwards if you're not careful.

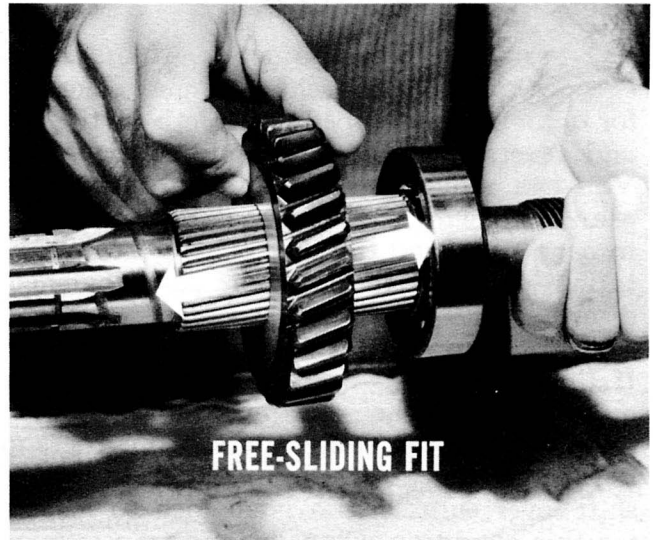
Fig. 20—Test reverse sliding gear

When you place the low and reverse sliding gear on the mainshaft, slide it the full length of the splines a few times to be sure there is absolutely no binding. On the 745 heavy-duty standard manual transmission, this is especially important if the service complaint is a condition of "hanging up" in low gear. If you find any binding, no matter how slight, try removing the gear and rotating it one spline, before you put it back on. If necessary, continue to change the mating of the splines until you find a smooth-sliding combination.

If the gear still binds, polish down the major diameter of the mainshaft splines with fine

abrasive cloth. Then clean it thoroughly and try the gear again. If binding is still present, you may have to select-fit a new low and reverse sliding gear to the mainshaft.

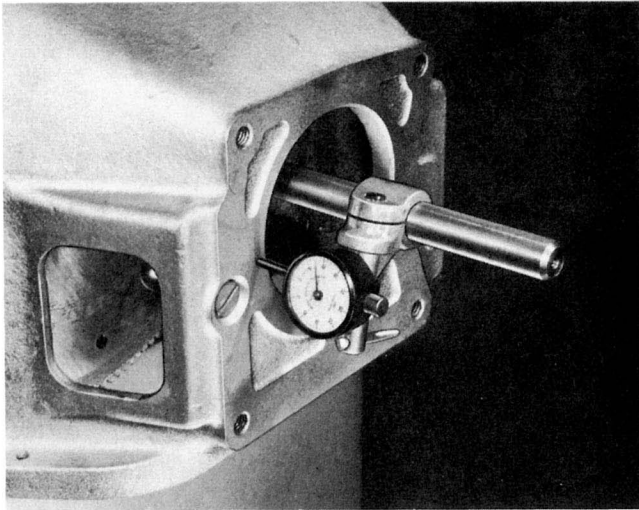
Fig. 21—Measure clutch housing bore and face runout

Alignment of the transmission is determined by measuring the clutch housing bore and face

runout with the special tool C-870 and a dial indicator. See your Service Manual for the full story on the permissible limits and adjustment procedures.

If the transmission is not correctly aligned with the crankshaft centerline, clashing of gears when shifting into low or reverse and popping out of gear will result. Premature wear of the drive pinion pilot bushing in the end of the crankshaft and of the pilot bearing in the end of the pinion shaft, as well as breakage of clutch disc damper springs, are other possibilities.
